# **A Structural Reevaluation of the Collapse of World Trade Center 7**

***Draft***

**INE Report 18.17**

**September 2019**

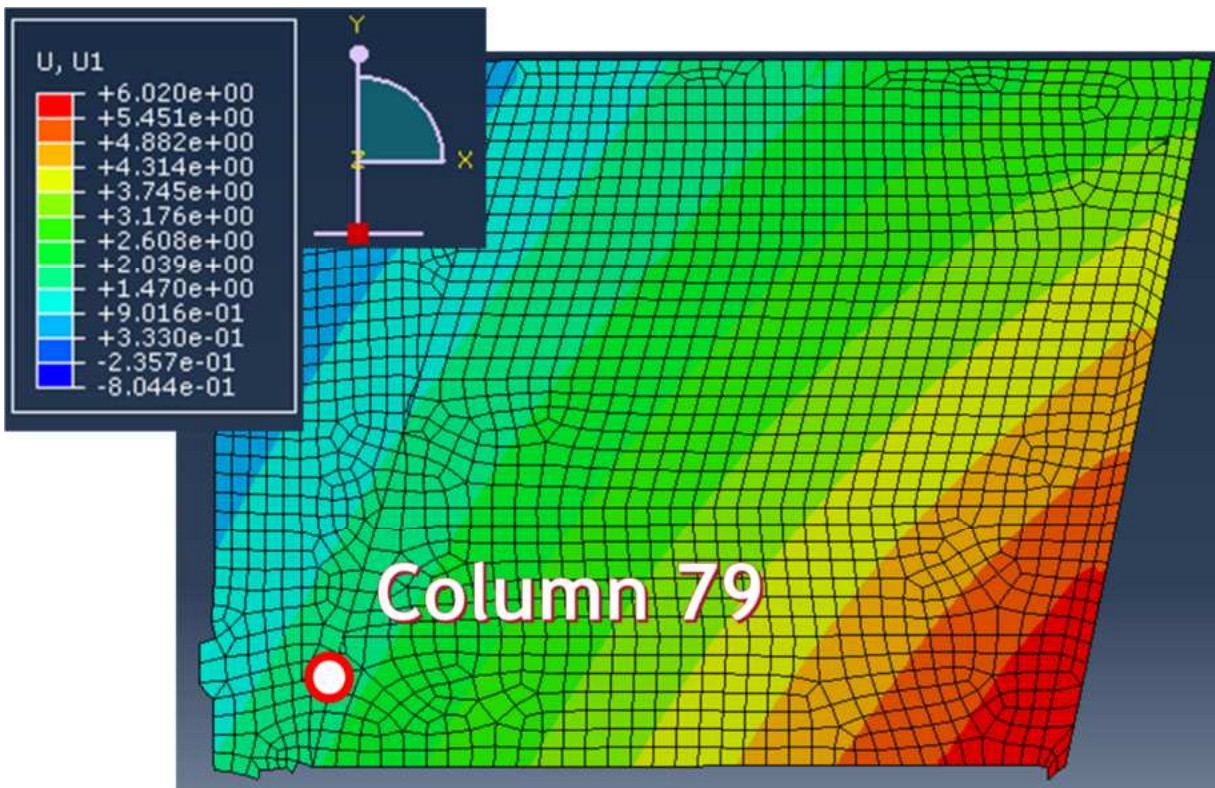
- Therefore, during our analysis of WTC 7's response to fire loading (Section 2.6), we found the overall thermal movements at the A2001 base plate support near Column 79 were not sufficient to displace girder A2001 to the point that it walked off its seat (the initiating failure alleged by NIST). Whereas NIST asserted that the differential westward displacement of girder A2001 relative to Column 79 was 5.5 inches and later revised its calculation to 6.25 inches, we found that the westward displacement of girder A2001

relative to Column 79 would have been less than 1 inch under the fire conditions reported by NIST.

Figure 2.62 Movement in  $x$ -direction at Floor 13 around Column 79.

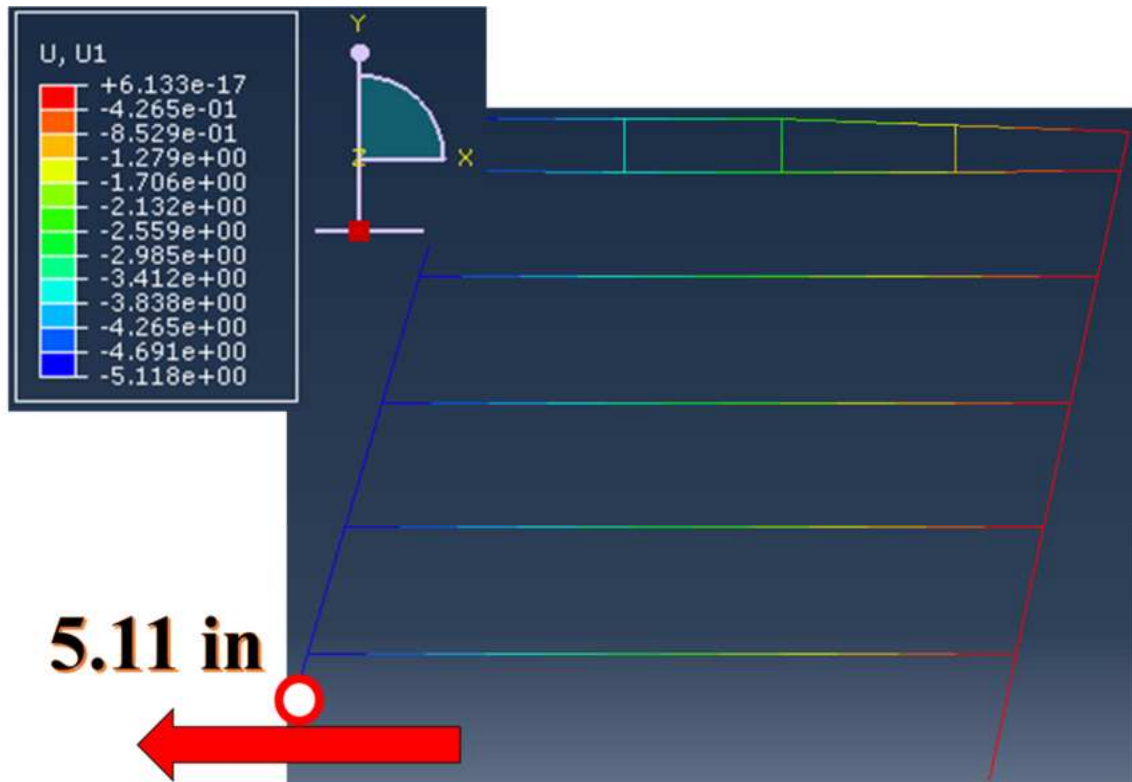
Figure 2.65 Transverse displacement at the end of A2001 using the NIST assumptions.

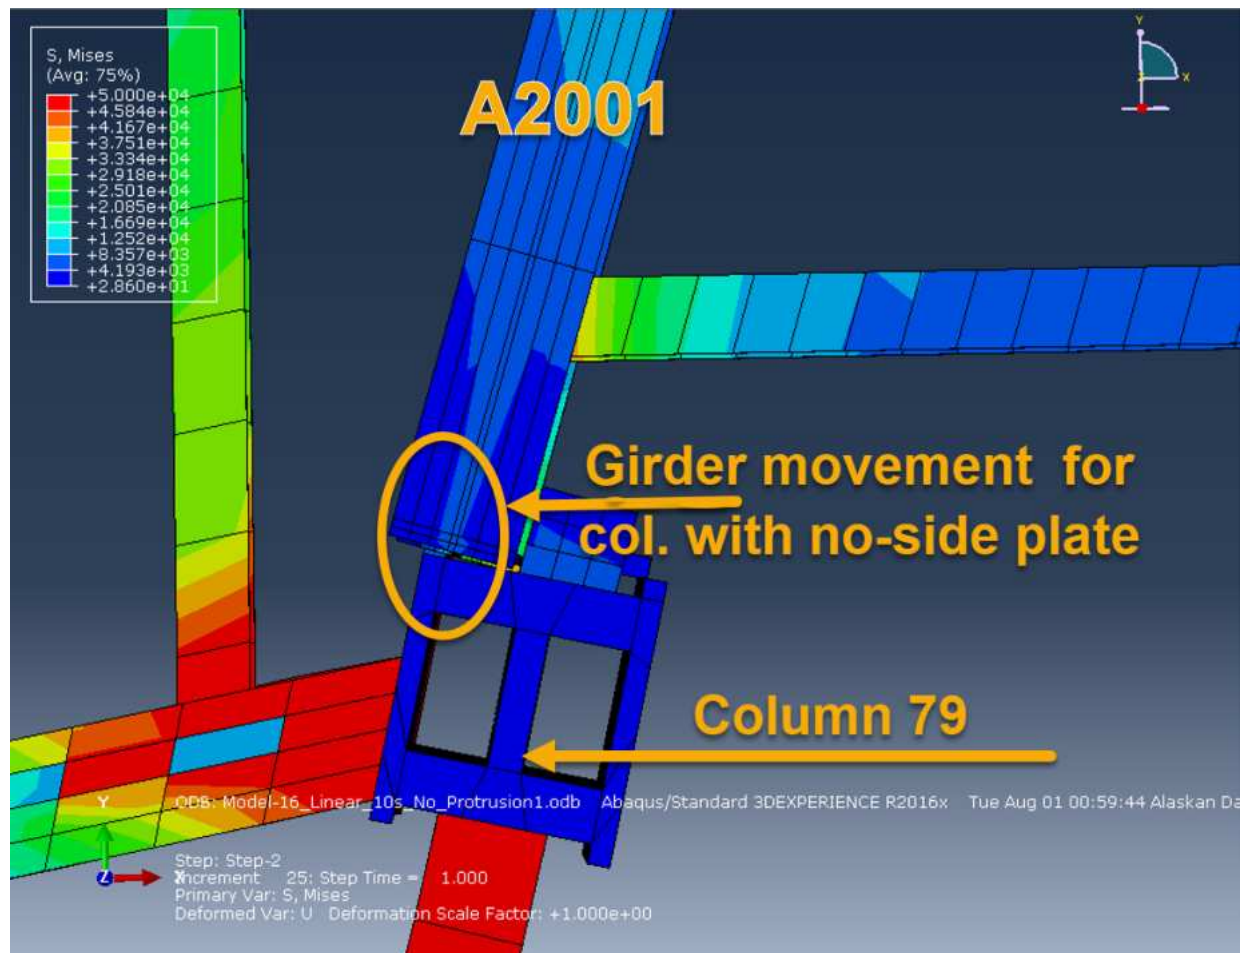
Figure 3.6 Plan view shows girder A2001 being pushed laterally past notched western side plate.

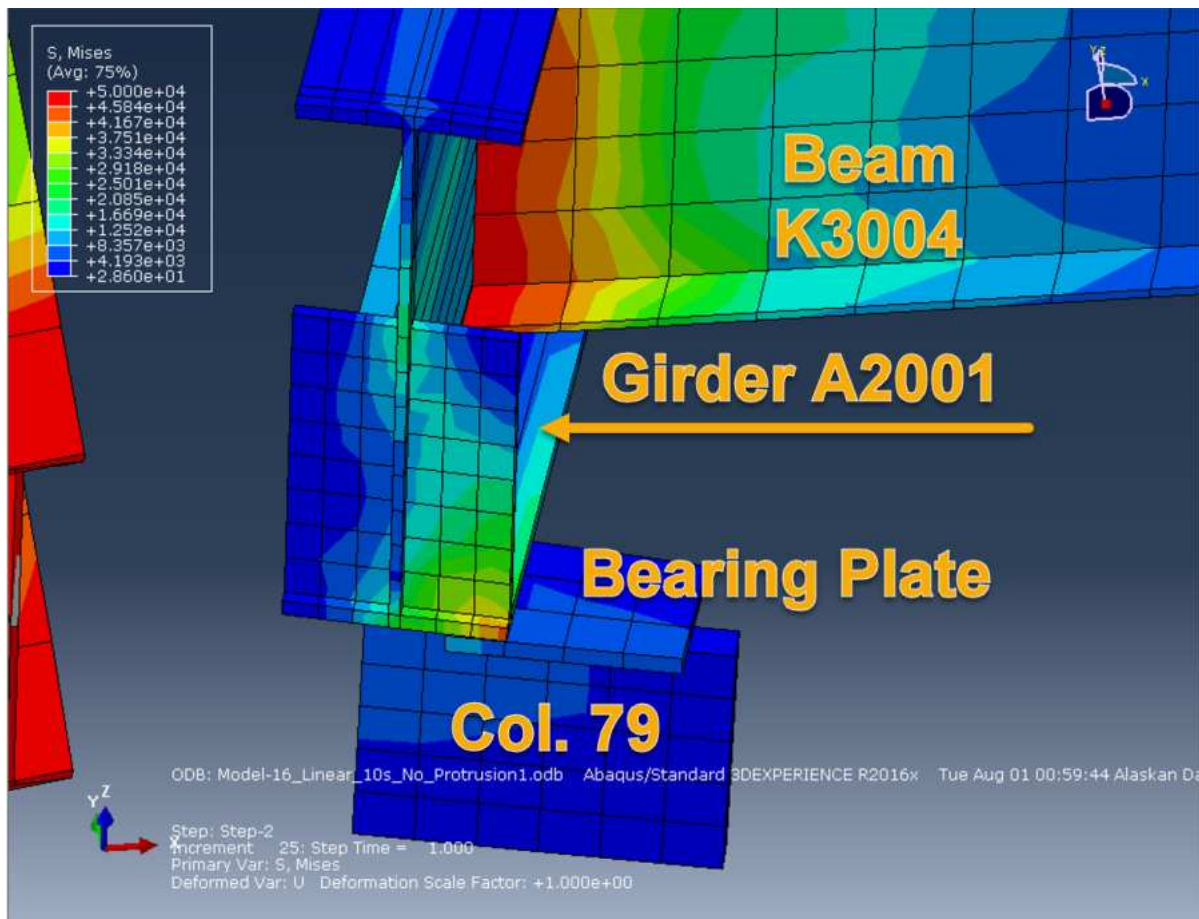
Figure 3.7 Analysis showing girder web A2001 pushed laterally past the bearing seat at Column 79. The column is removed for clarity.

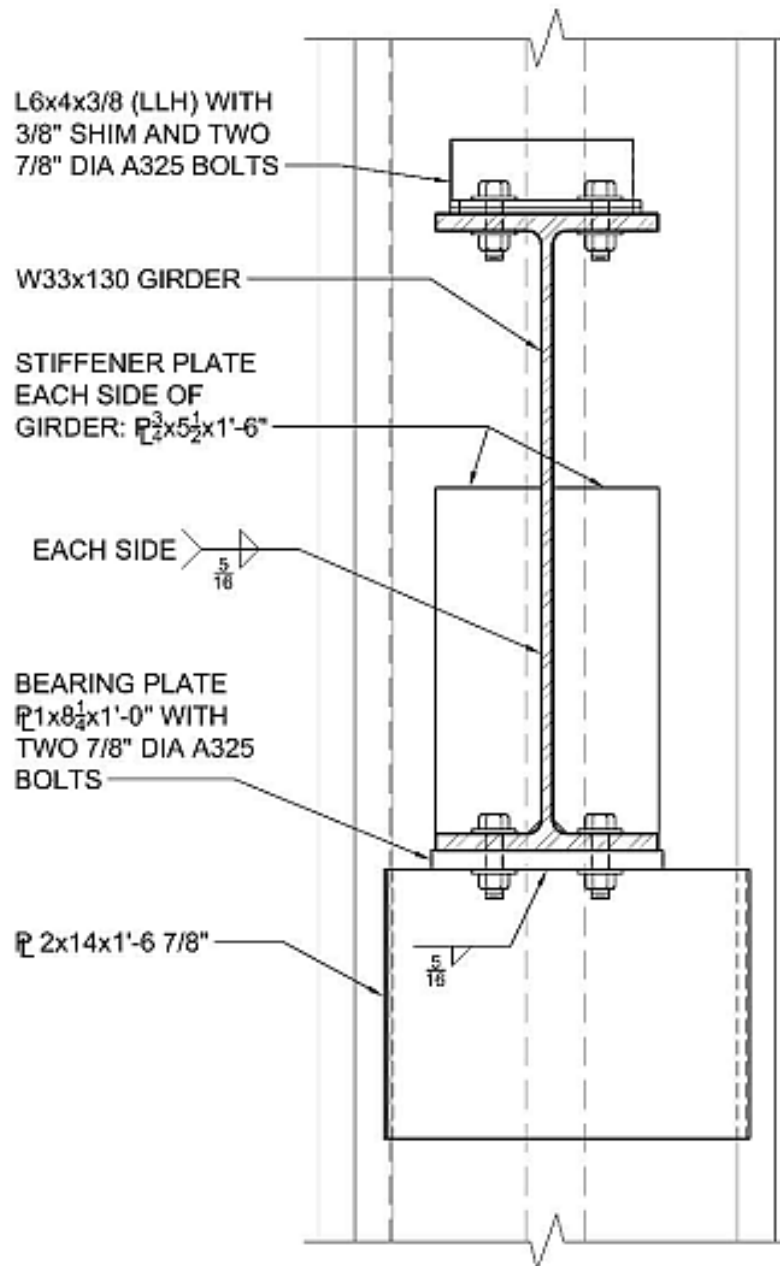
- NIST, by its own admission, did not include the partial height web stiffeners known to be on girder A2001. In addition to stiffening the web, these stiffeners significantly increase the bending resistance of the flange. In a subsequent analysis where we removed the side plate described in the previous analysis in order to allow for further westward travel of girder A2001, we found that the stresses in the girder flange and stiffener would not be sufficient to cause the flange to fail, thus preventing the girder from walking off its seat (Section 3.2.2).

Figure 3.10 Section view at Floor 13 of Column 79 and girder A2001 seated beam connection, which shows stiffener plates on girder A2001 (Data from Frankel Steel Limited, 1985, Drawing 9114; figure prepared by Brookman, 2012).

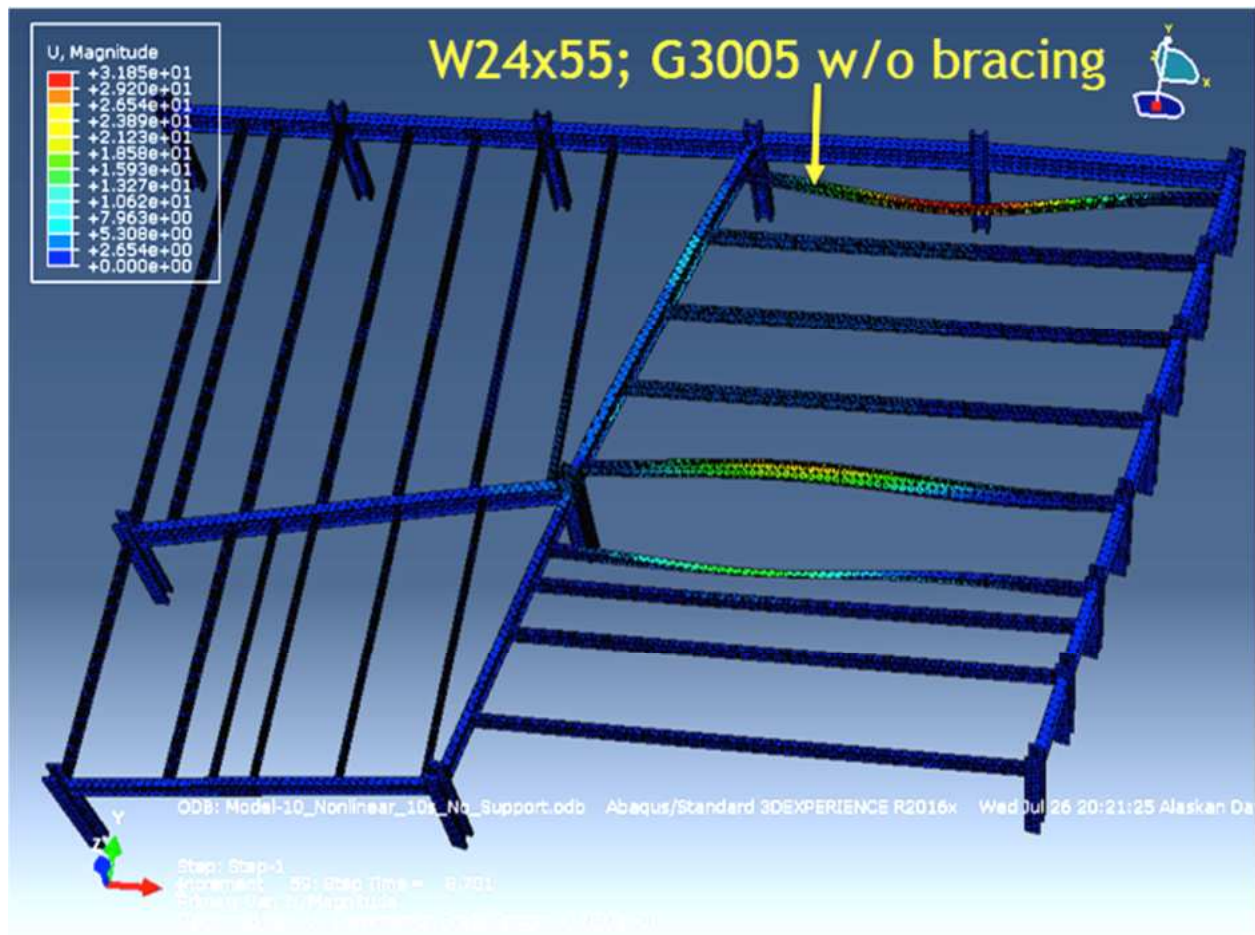
- In a preliminary collapse initiation hypothesis, NIST posited that beam G3005 buckled because its thermal expansion was restrained by girder A2001. We found that this can happen only when the three lateral support beams S3007, G3007, and K3007 spanning from beam G3005 to the north exterior wall are not included in the model. While these short beams are observed in some of the figures in the NIST report, they are missing from

Figure 3.14 UAF analysis of the W21x44 G3005 with no lateral support beams included.

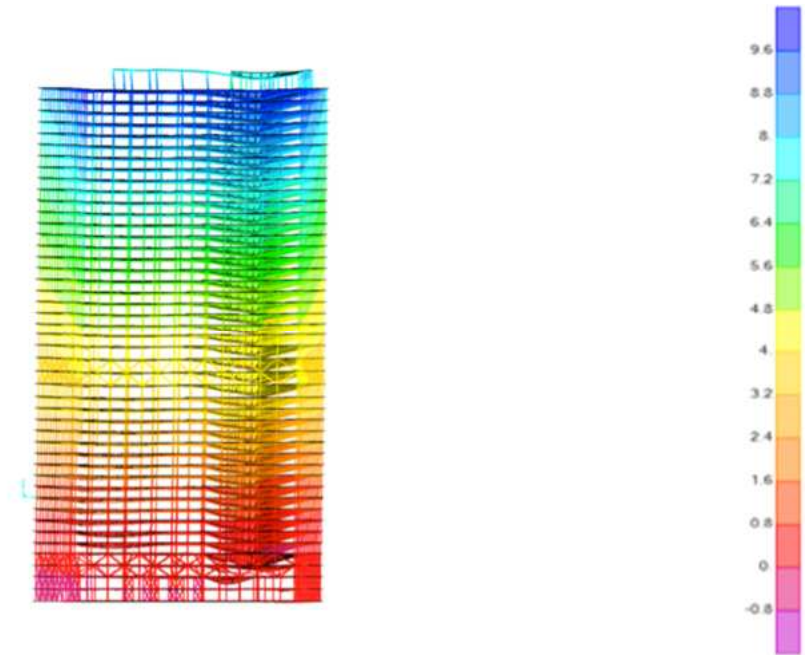
Figure 4.2: Columns 79, 80, and 81 are removed from Floor 6 to Floor 13. The building tilts to the east almost 10 inches. The penthouse does not collapse.

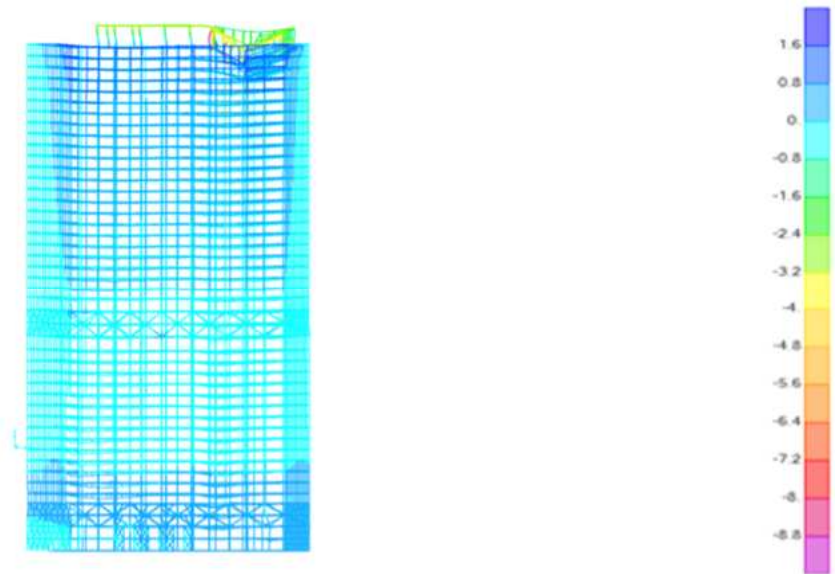
Figure 4.7: Columns 79, 80, and 81 are removed from Floor 45 to the penthouse. Tilting of the building is now negligible. The penthouse now collapses, as demonstrated from the significant amount of deflection given in the figure.

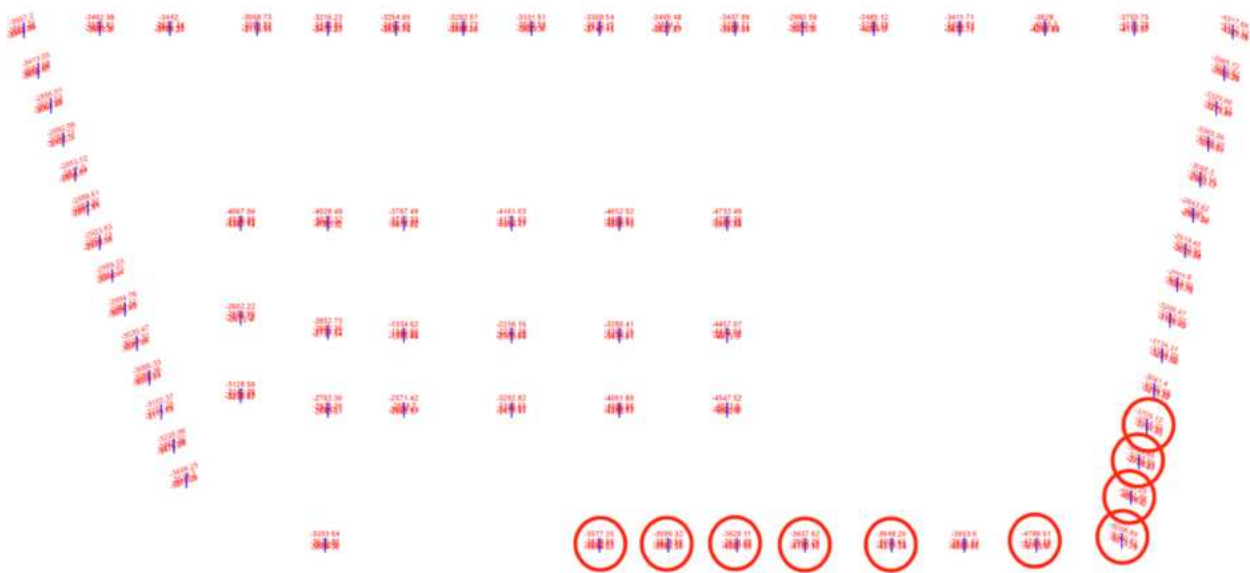
Figure 4.10: Linear static analysis results show that the failure of Columns 76 to 81 overloads 10 exterior columns (circled in red) around the southeast corner, but not the next row of core columns to the west (not circled in red).

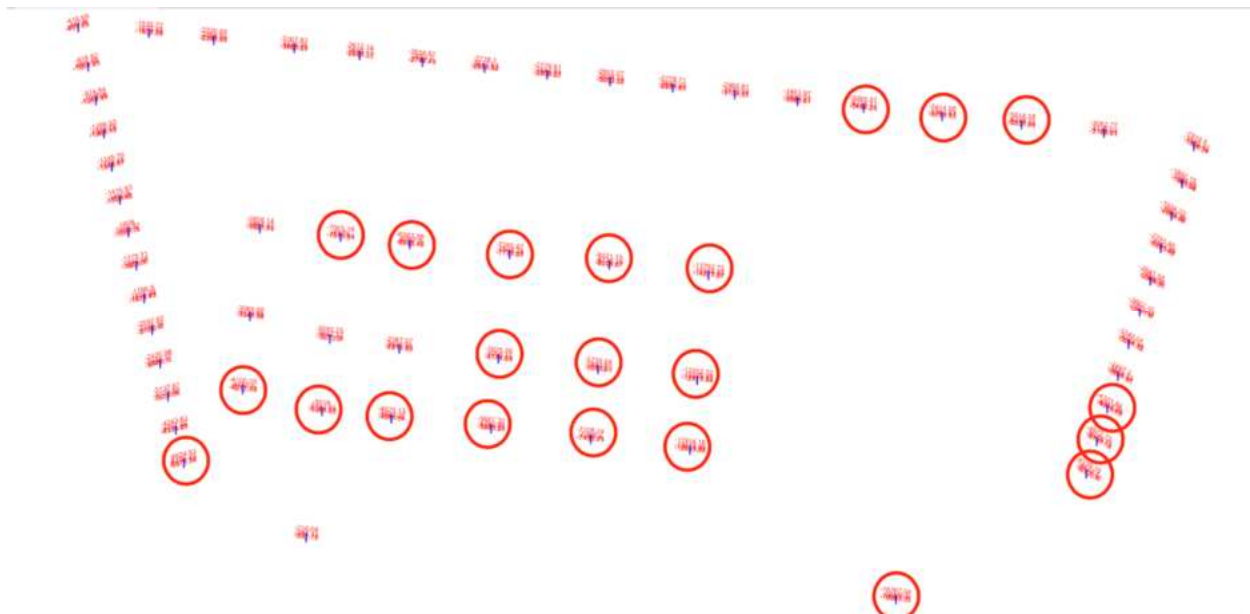
Figure 4.11: Linear static analysis results show that the failure of 10 exterior columns around the southeast corner leads to numerous core and exterior columns (circled in red) being overloaded and failing. A progressive collapse triggered by the hypothetical failure of Columns 76 to 81 is underway.

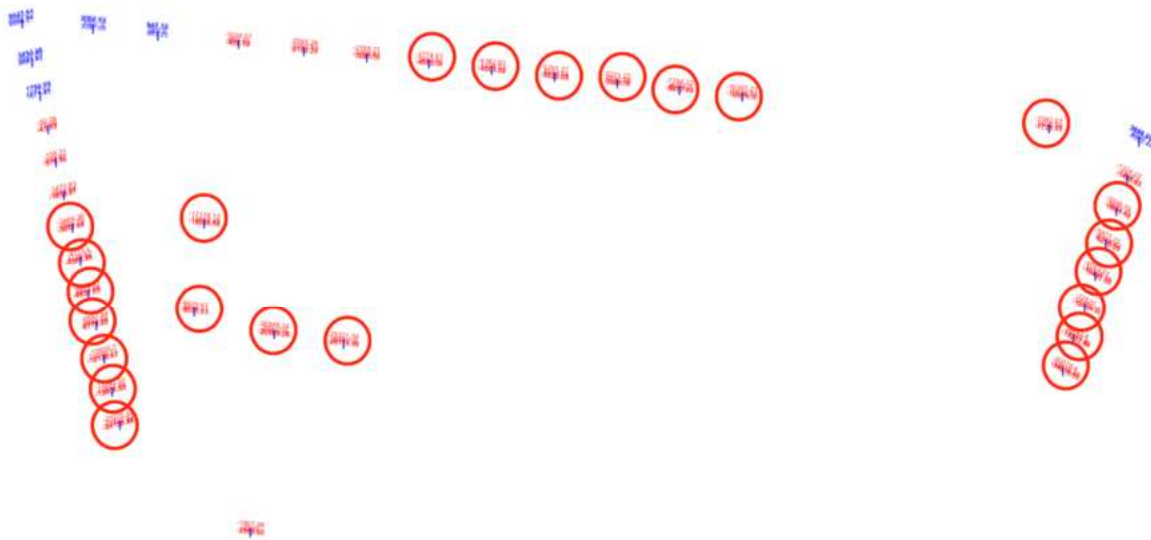
Figure 4.12: Linear static analysis results show that the failure of additional columns (shown in Figure 4.11 above) leads to the failure of the remaining core columns and many exterior columns (circled in red). The columns with blue values are in tension rather than compression, indicating the building is tipping away from those columns.

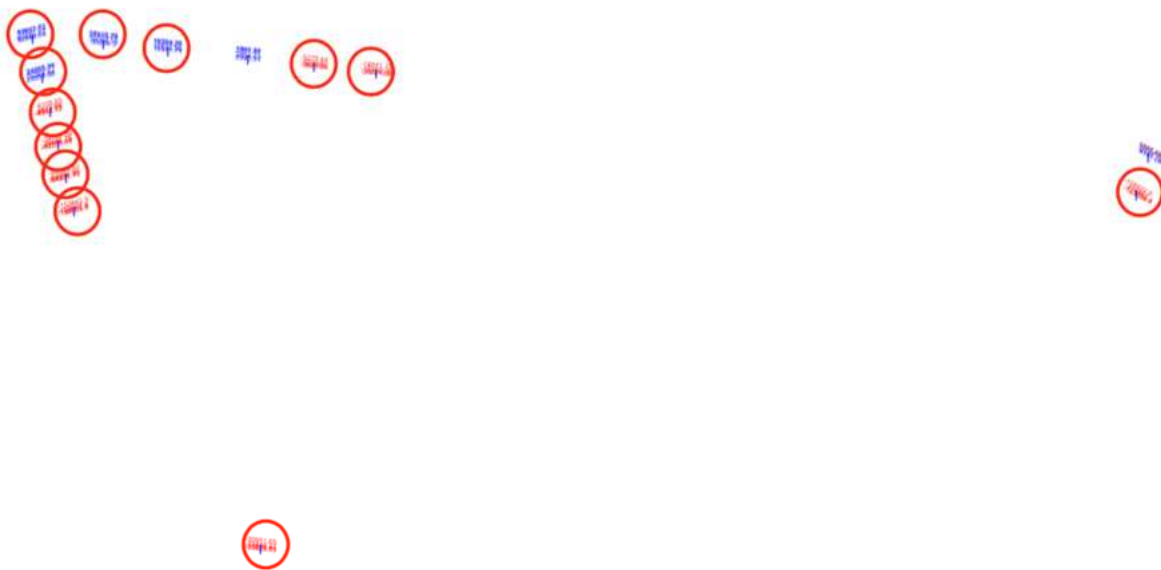
Figure 4.13: Linear static analysis results show that the failure of additional columns (shown in Figure 4.12 above) leads to the failure of nearly every remaining column (circled in red).

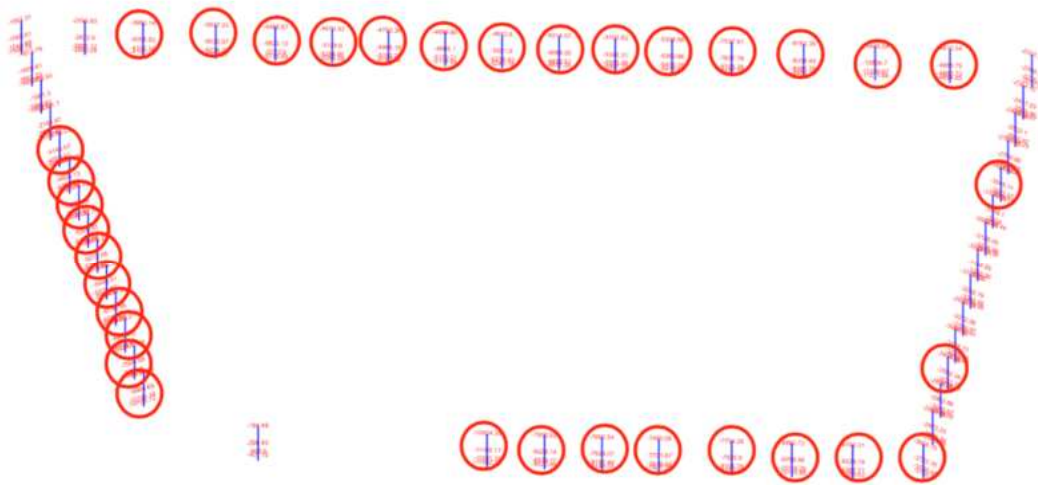
Figure 4.17: Linear static analysis results show that the simultaneous failure of all core columns leads to the failure of most exterior columns, causing the building to tip to the southwest. Only columns at the northwest corner and eastern side are not overloaded.

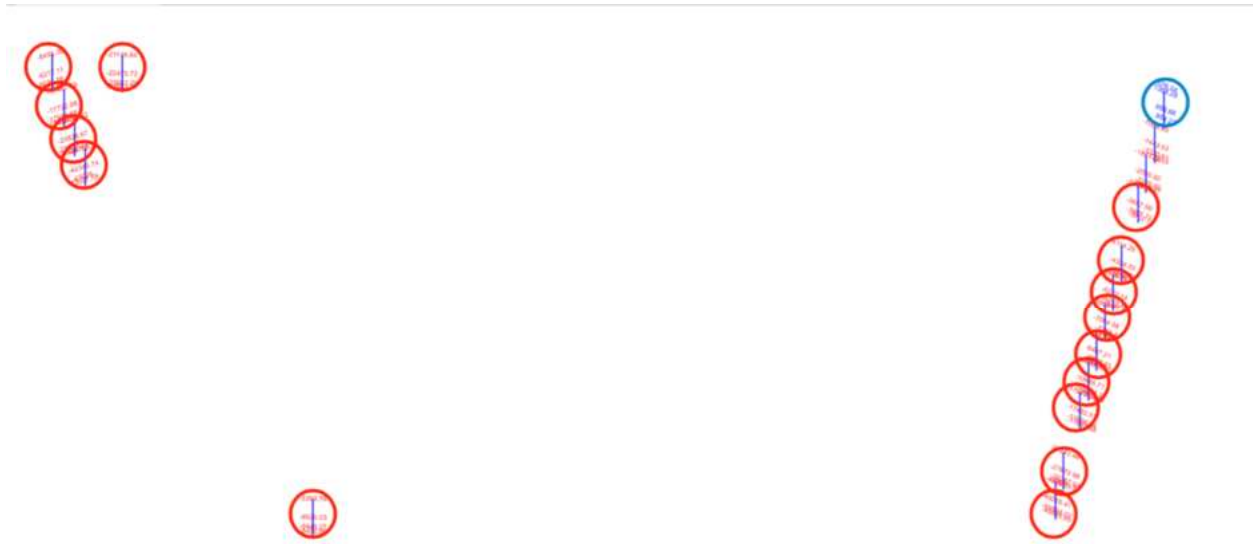
Figure 4.18: Linear static analysis results show the failure of nearly all remaining columns. The northeast column with blue values is in tension as the building tips away to the southwest.

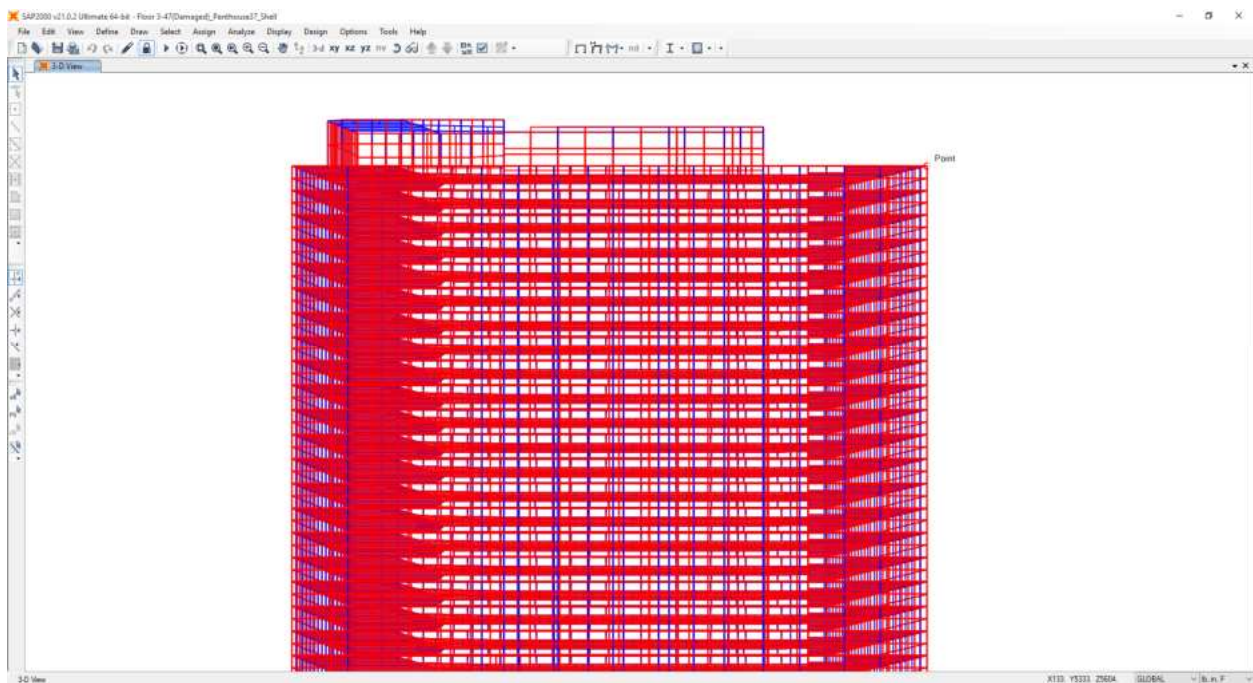
This conclusion is based primarily upon the finding that the simultaneous failure of all core columns over 8 stories followed 1.3 seconds later by the simultaneous failure of all exterior columns over 8 stories produces almost exactly the behavior observed in videos of the collapse, whereas no other sequence of failures that we simulated produced the observed behavior. We cannot completely rule out the possibility that an alternative scenario may have caused the observed collapse; however, the near-simultaneous failure of every column is the only scenario we identified that was capable of producing the observed behavior.

Figure 4.22: Simulation of core column-exterior column failure scenario.
