# **A Structural Reevaluation of the Collapse of World Trade Center 7**

***Draft***

**INE Report 18.17**

**September 2019**

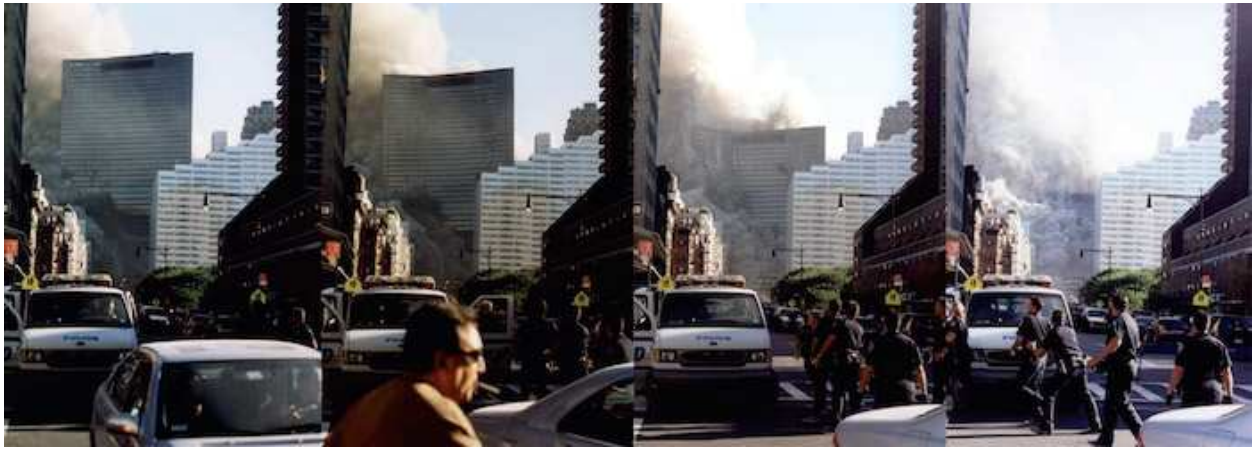
Figure 1.5 The collapse of WTC 7 at 5:20 PM (source unknown).

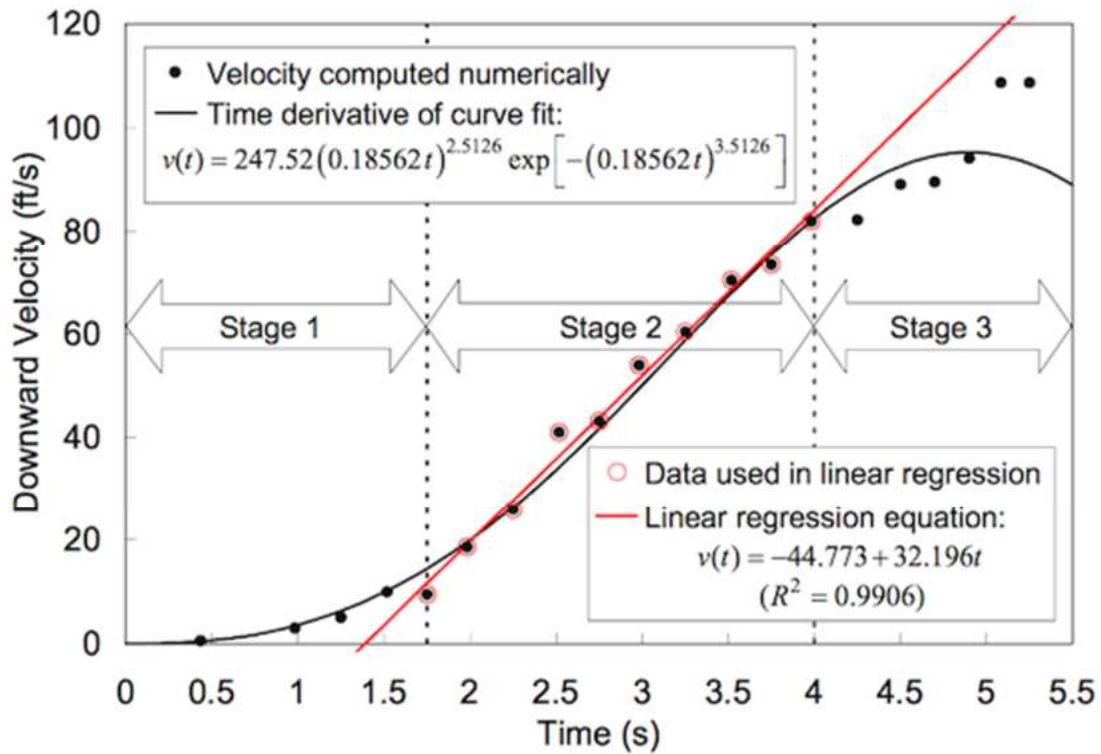
1. WTC 7 experienced between 2.25 and 2.5 seconds of free fall (i.e., gravitational acceleration) during its collapse. This fact was first identified by independent researcher David Chandler and later corroborated by NIST (Figure 1.6). WTC 7's free fall is noteworthy because, in a typical building collapse, WTC 7 would be expected to experience a combination of axial rotation and bending of members, resulting in a disjointed, asymmetrical collapse. Asymmetrical, tipping behavior is especially likely because WTC 7 did not have planar symmetry.

Figure 1.6 WTC 7 was in free fall for approximately 2.25 seconds over a distance of approximately 8 stories or 32.0 meters (NIST, 2008, NCSTAR 1A).

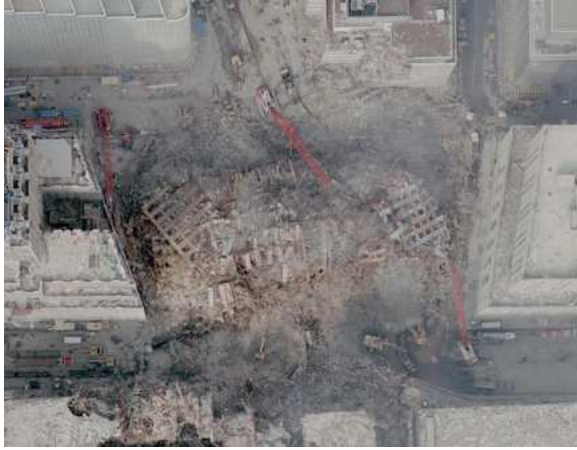
2. The debris pile of WTC 7 was contained mostly inside the building's footprint. Furthermore, it did not have large pieces of concrete flooring or intact structural framing that would be expected in a building collapse (see Figure 1.7).

Figure 1.7 WTC 7 debris pile (NOAA, September 23, 2001).

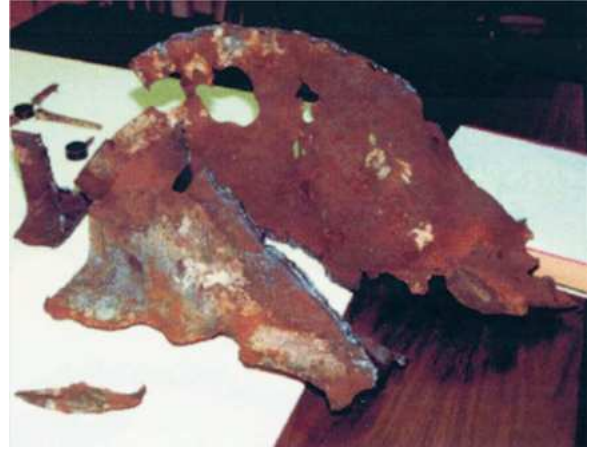
3. According to Appendix C of FEMA's May 2002 report, a steel member recovered from WTC 7 was found to have experienced corrosion due to a combination of oxidation and sulfidation at 1,000°C, resulting in the formation of a liquid eutectic (see Figure 1.8). Researchers have hypothesized that the presence of thermate, which is a form of thermite

incendiary that includes sulfur, would explain the sulfidation and formation of a liquid eutectic (Jones, 2006 and 2007).

Figure 1.8 Steel from WTC 7 that experienced oxidation and sulfidation (FEMA, 2002).

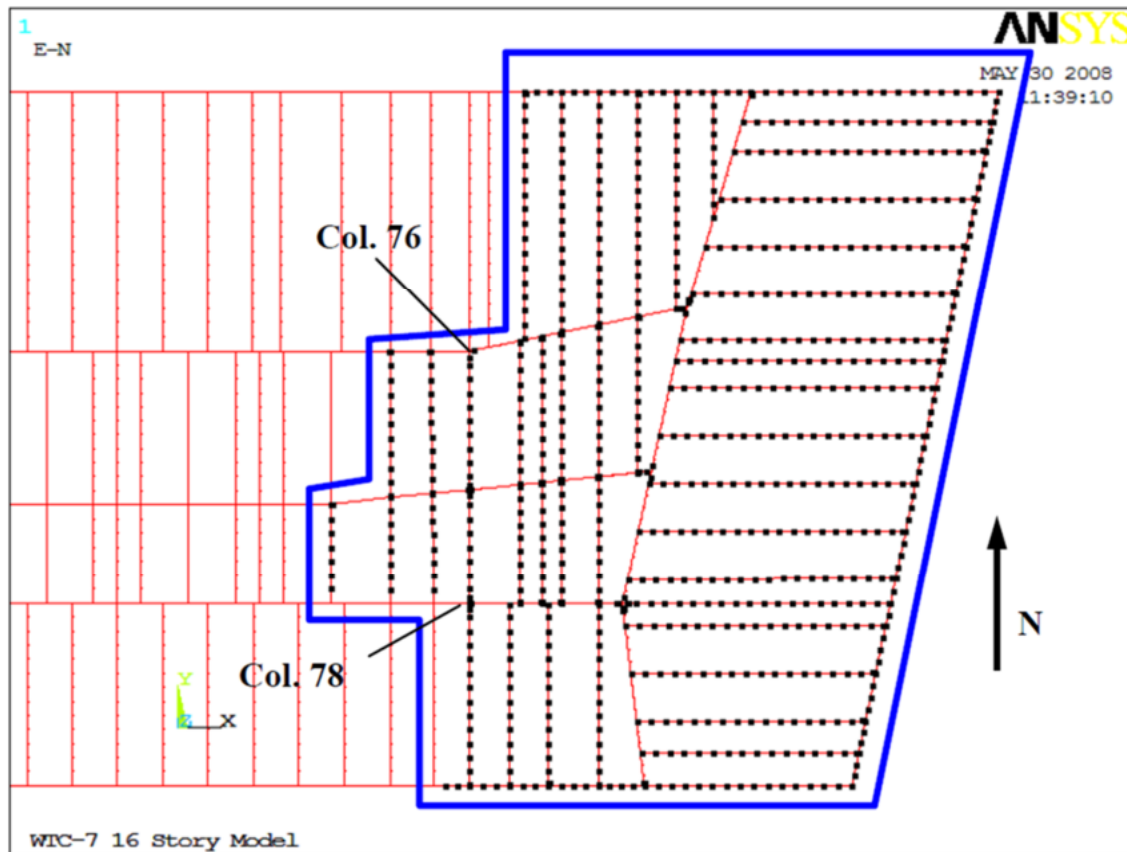
In the NIST investigation, the failure of the floor-framing connections and the shear studs was modeled with break elements on Floors 8 to 14. Outside the selected area in Figure 2.4 shown below, structural damage — such as buckling of the steel frame and crushing and

cracking of the concrete slab — was modeled over the entire floor, but connection failures were not modeled over the entire floor. Connections were also not modeled in the exterior moment frame, as no failures were observed there prior to the onset of global collapse (NIST, 2008, NCSTAR 1A).

Figure 2.4 Area of floor where connection failure was modeled by NIST

First, by not modeling connections in the outside frame, NIST overestimated the rigidity of the outside frame. That assumption and inconsistent modeling for the framing connections resulted in the stiffness of the east side of the building being different than that of the west side. This resulted in the stiffness being compromised across the plan of the building.

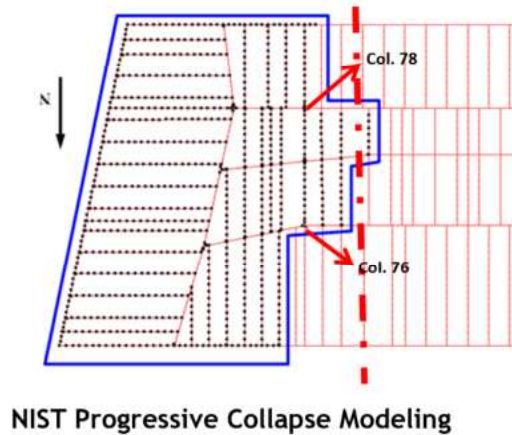
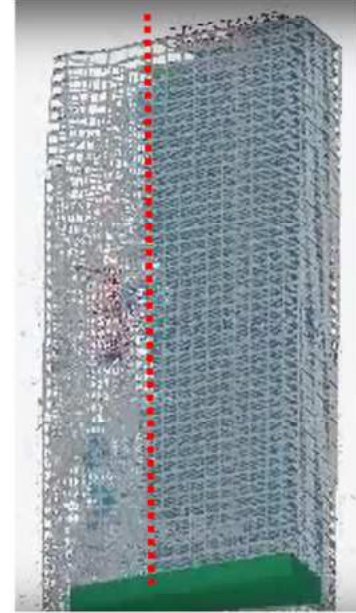
The NIST simulation of the collapse illustrated that the west side of the building acted differently from the east side. The structural response to failure would more closely resemble the actual collapse if the connections had been accounted for throughout the structural frame. By not modeling the connection failures outside the selected area shown in Figure 2.4 above, NIST appears to have reduced the stiffness in the area outside the selected area and separated its progressive collapse simulation into two parts (see Figure 2.5).

**Connections were not modeled;  
outside selected blue space.**

Figure 2.5 Progressive collapse separated into two parts.

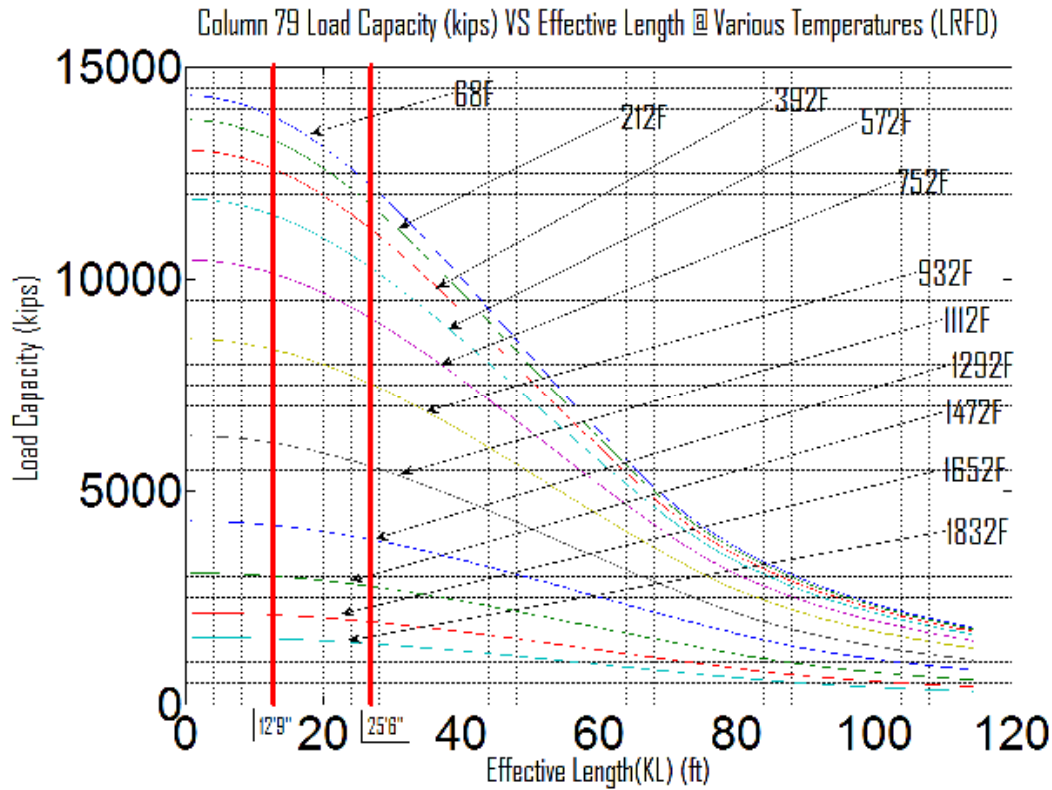
Column 79 at Floor 13 was a built-up column consisting of W14×730 and two steel plates 2 inches thick by 26 inches wide welded on the sides. Figure shows the cross section of Column 79. Figure 2.16 shows the mechanical properties of steel against temperature (Engineeringtoolbox, 2011). A buckling analysis was conducted for Column 79 according to the AISC Steel Construction Manual (AISC, 2011). Figure 2.17 shows the load capacity of Column 79 versus the effective length at different temperatures assuming a pinned-pinned condition. The two red lines mark the effective length of 12 feet 9 inches and 25 feet 6 inches. The two effective lengths are the single floor height and the double floor height. The loading capacity of Column 79 at double floor height (25 feet 6 inches) would be the load capacity of the column during the fire if Column 79 were to lose its support on one floor.

Figure 2.17 Load capacity of Column 79 versus effective length at different temperatures.

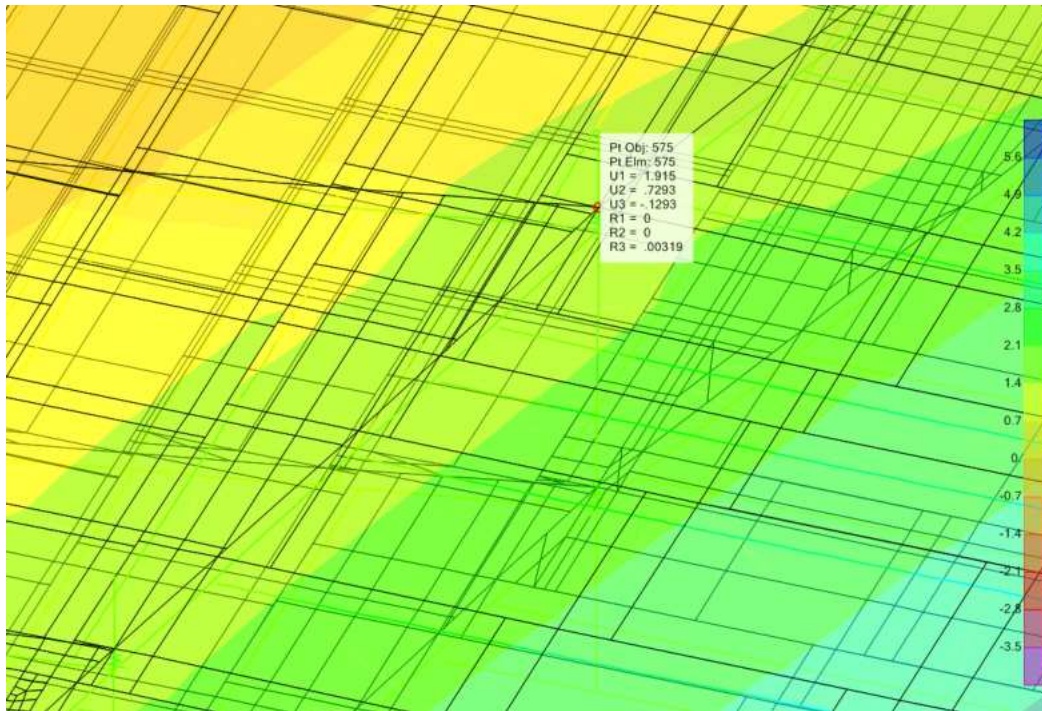
Figure 2.58 shows the displacement of the floor system surrounding Column 79. The displacement at Column 79 in the  $x$ -direction was 1.915 inches east (and not west), and the displacement at Column 79 in the  $y$ -direction was 0.7293 inches. Note that this is the overall displacement of the floor system. The westward displacement of girder A2001 relative to Column 79 was found to be less than 1 inch, which differs substantially from the 6.25 inches of westward movement of girder A2001 reported by NIST. We believe this is because NIST treated

the exterior frame as infinitely stiff and fixed it against horizontal movement. Our analysis was based on using the actual external frame stiffness, which was very flexible.

Figure 2.58 Displacement (inches) of the floor system surrounding Column 79.

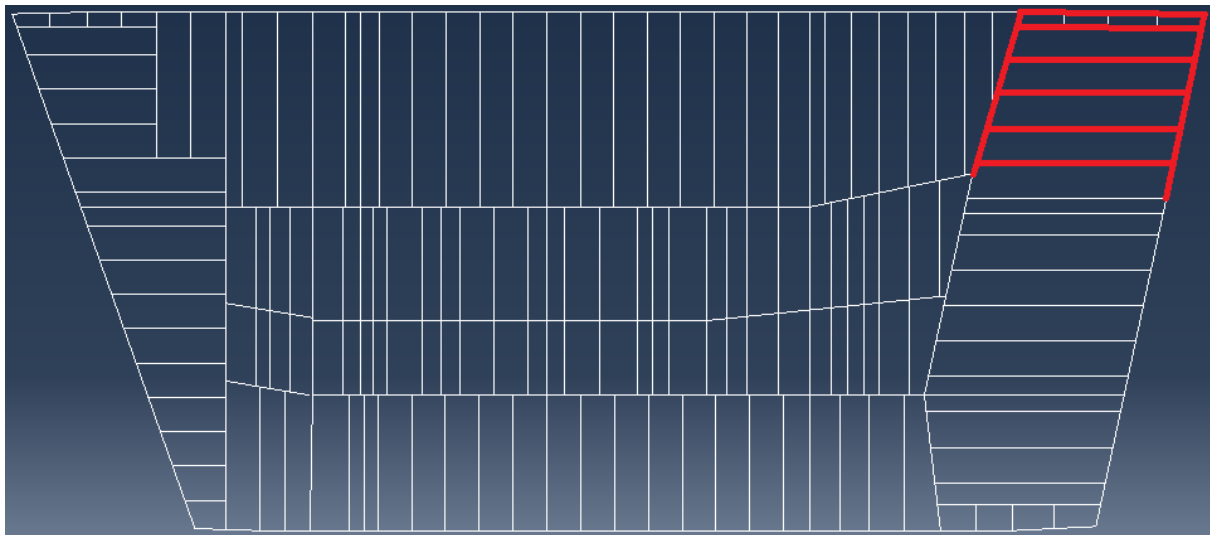
Figure 2.63 The part of the Floor 13 frame we examined is shown in red.

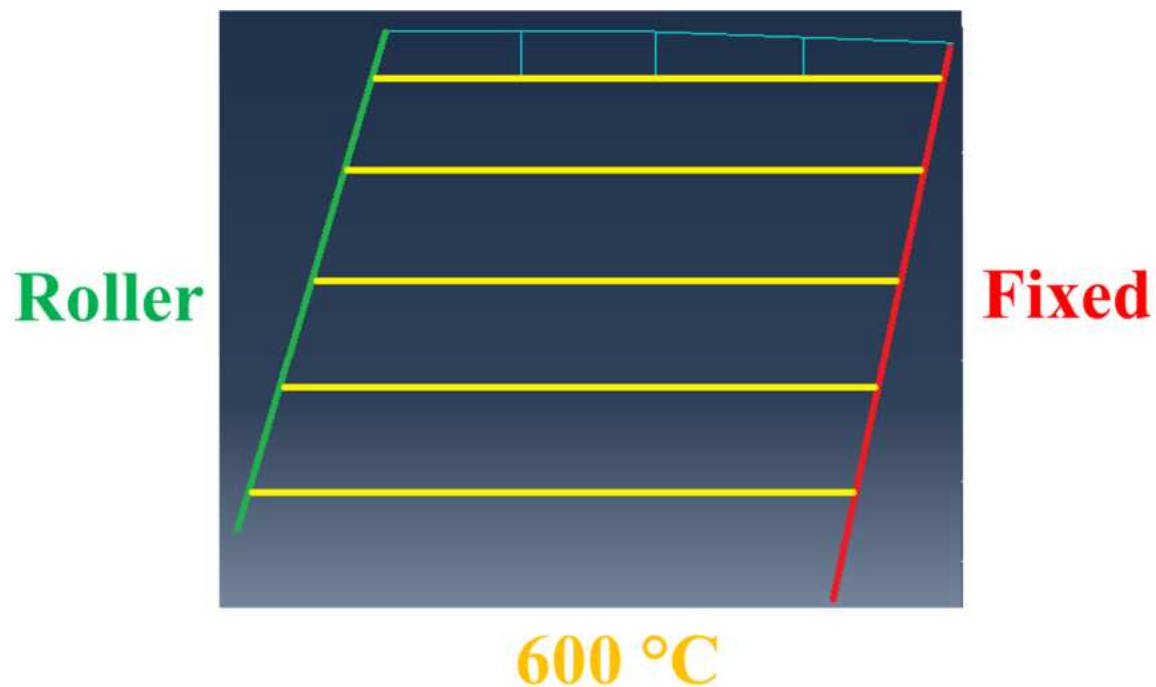
When we incorporate NIST's boundary conditions and remove all restrictions to lateral movement, such as the Column 79 side plates, we find that the westward displacement of girder A2001 relative to Column 79 is 5.11 inches, which is a full inch less than the 6.25 inches of westward relative displacement reported by NIST, and nearly an inch less than the 6 inches westward displacement required to push the web of girder A2001 past its 12-inch seat at Column 79.

Figure 2.64 Local frame boundary conditions reported by NIST.

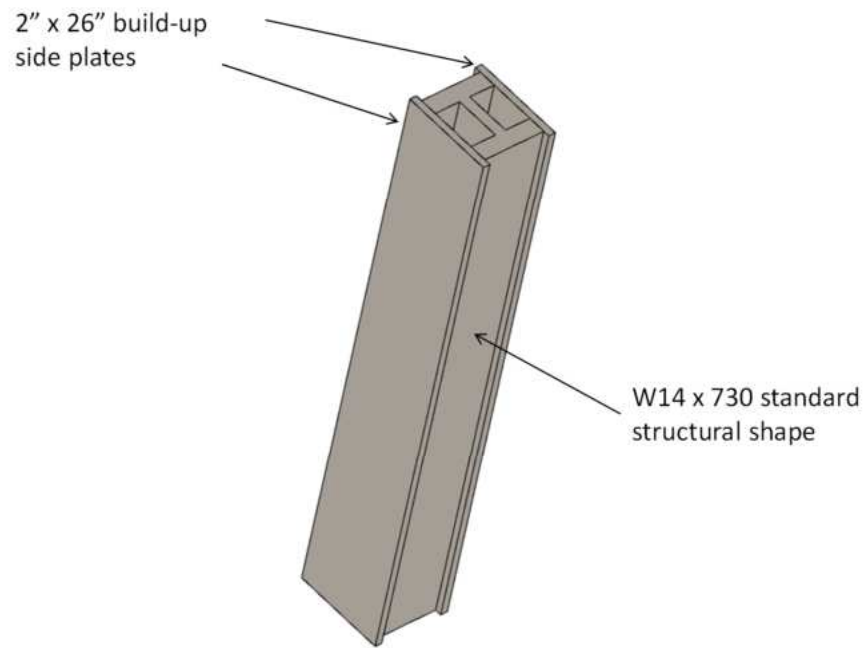
Figure 3.3 shows the built-up configuration of Column 79 with its protruding side plates. Using the assumptions made by NIST, we analyzed the thermal response of Floor 13.

Figure 3.3 Column 79 section showing side plates welded to a W14x730.

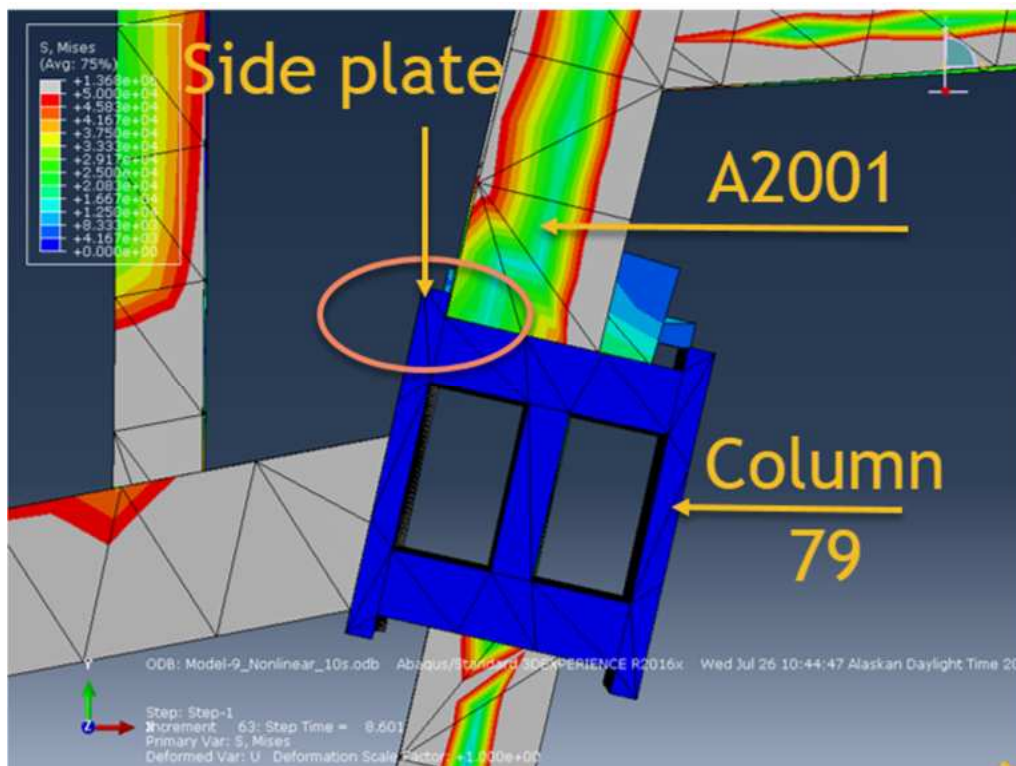
First, we found that when girder A2001 is heated, it expands such that it becomes trapped behind the side plate on the western side of Column 79 as it is pushed to the west by thermally expanded beams K3004, C3004, B3004, A3004, and G3005 (see Figure 3.4).

Figure 3.4 Plan view showing girder A2001 trapped by the Column 79 side plate.

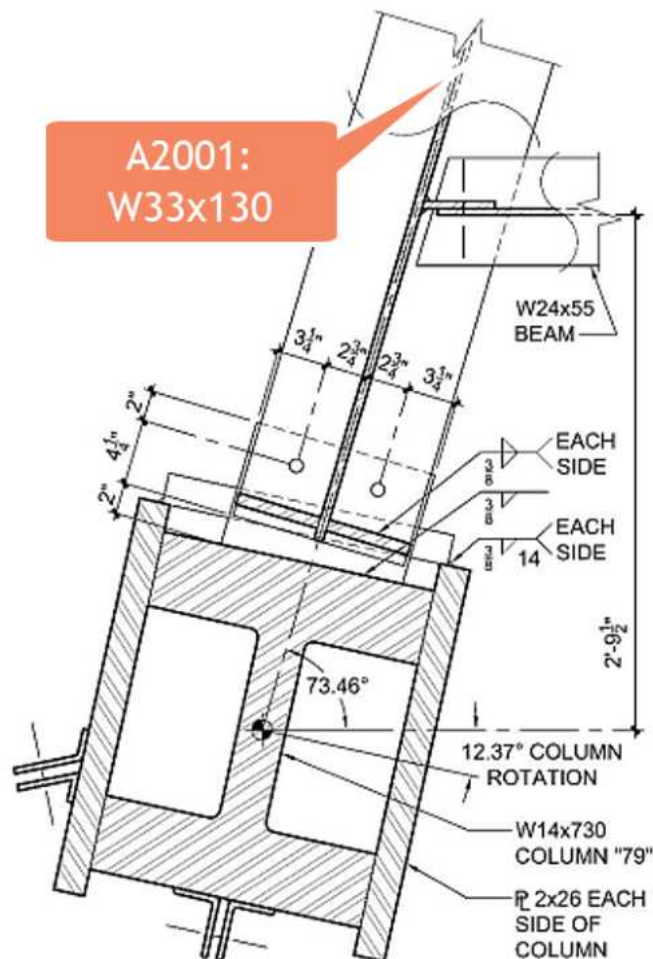
Figure 3.5 shows the girder bearing seat at Column 79 is 12 inches wide. The flange width for W33 x 130 girder A2001 is 11.510 inches wide and centered on the seat; its web is 0.580 inches thick. This would require a lateral travel distance of 6.290 inches for the web to be beyond the seat. However, the distance between the column side plates is 17.89 inches. The girder and bearing seat are slightly off center to the east, with just 3.678 inches between the girder's western edge and Column 79's western side plate. Thus, the side plate prevents the girder's web from traveling beyond the bearing seat.

Given that the Column 79 side plate prevents the girder's web from traveling beyond the bearing seat, it appears that the structural analysis performed by NIST either minimized the side plate protrusion on Column 79 (nominally 1.79 inches) or ignored it altogether.

Figure 3.5 Plan View for Floor 13 at Column 79 and girder A2001 seat connection (Data from Frankel Steel Limited, 1985, Drawing 9114; figure prepared by Brookman, 2012).

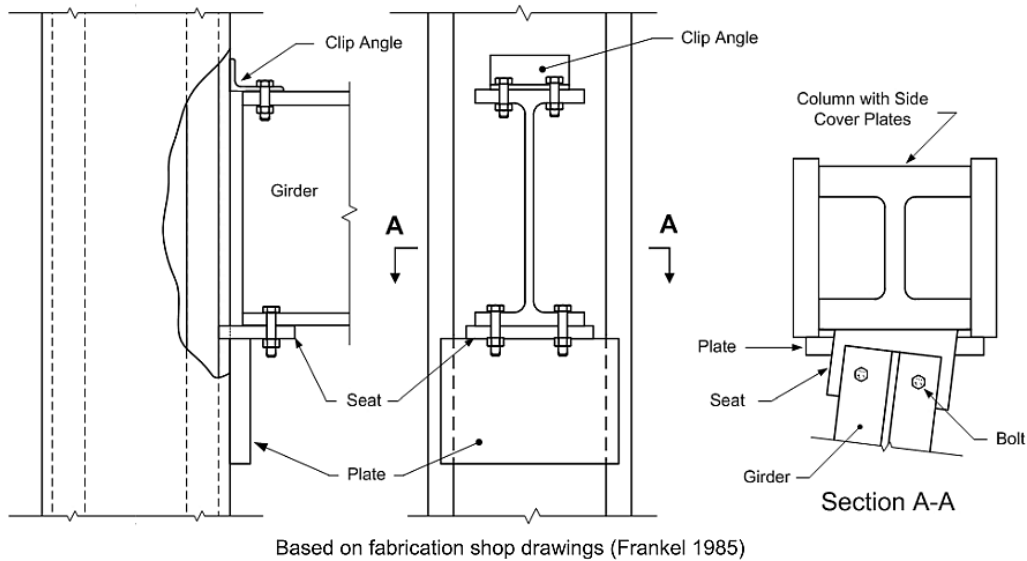
Figures 3.8 and 3.9 below, which are from the NIST report, show that the NIST report's drawing and analysis figures omit these web stiffeners. Figure 3.10 shows the actual configuration.

Figure 3.8 Drawing of Column 79 and girder A2001 seated beam connection shown in Figure 8-21 of the NIST report.

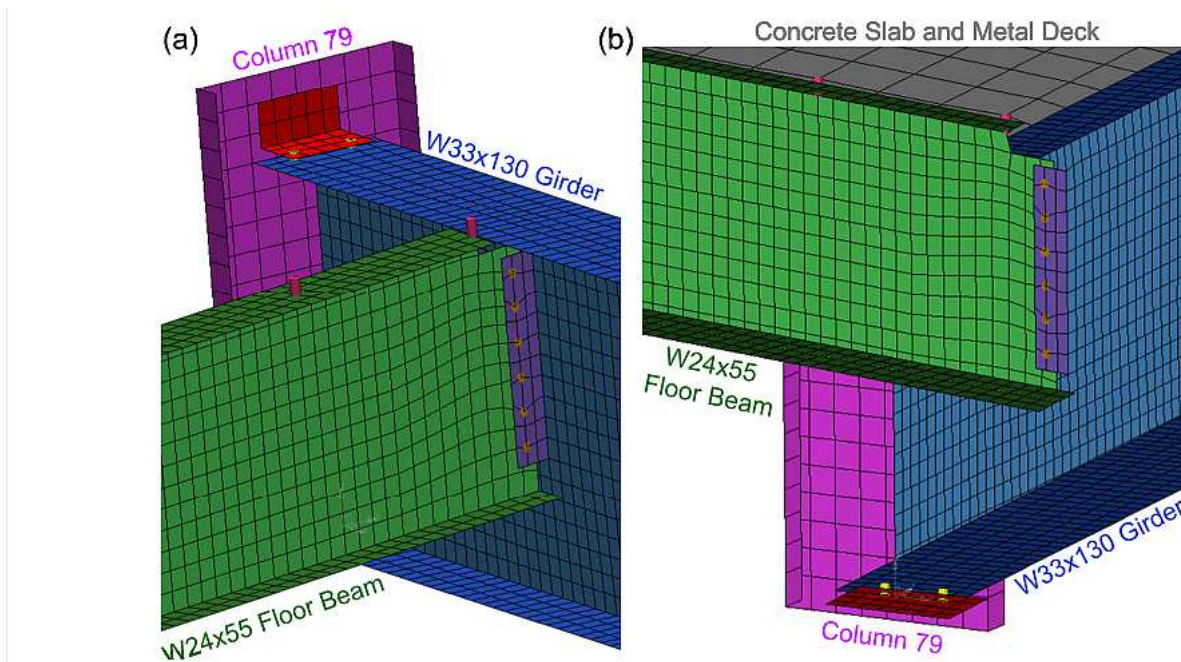
Figure 3.9 Figure 8-23 of the NIST report showing NIST's finite element analysis of the Column 79 and girder A2001 seated beam connection.

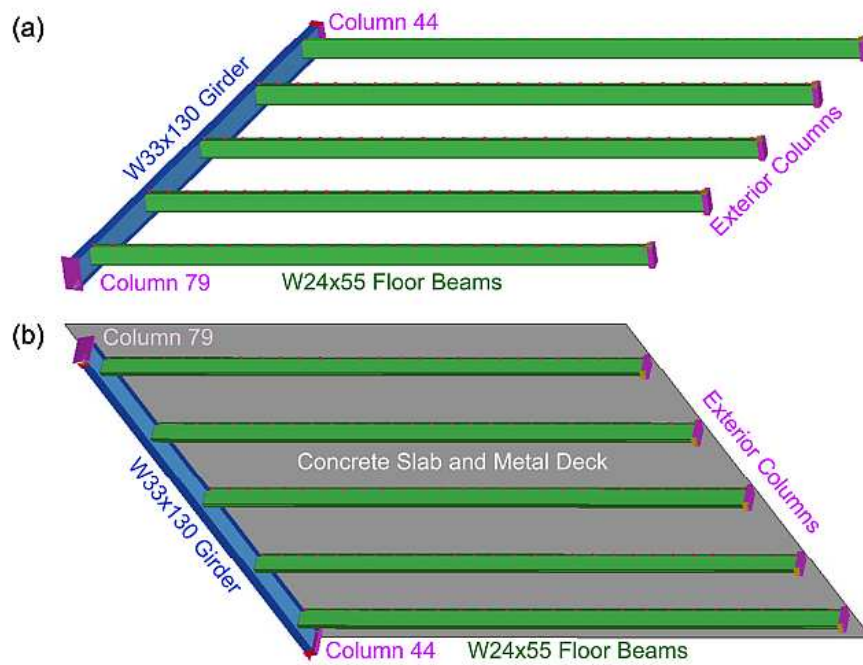
Figure 3.12 Figure 8-22 in the NIST report shows analysis results for G3005 with no lateral bracing condition (NIST, 2008, NCSTAR 1-9, Vol. 1, Page 350).

When the NIST constraints are followed, our analysis showed that beams D3004 and K3004 would have also buckled (see Figures 3.11 to 3.14). The NIST results were based upon erroneously selected boundary conditions, wherein NIST assumed the east exterior wall was extremely stiff and acted as a fixed restraint against thermal movements. As discussed previously, this was not the case.

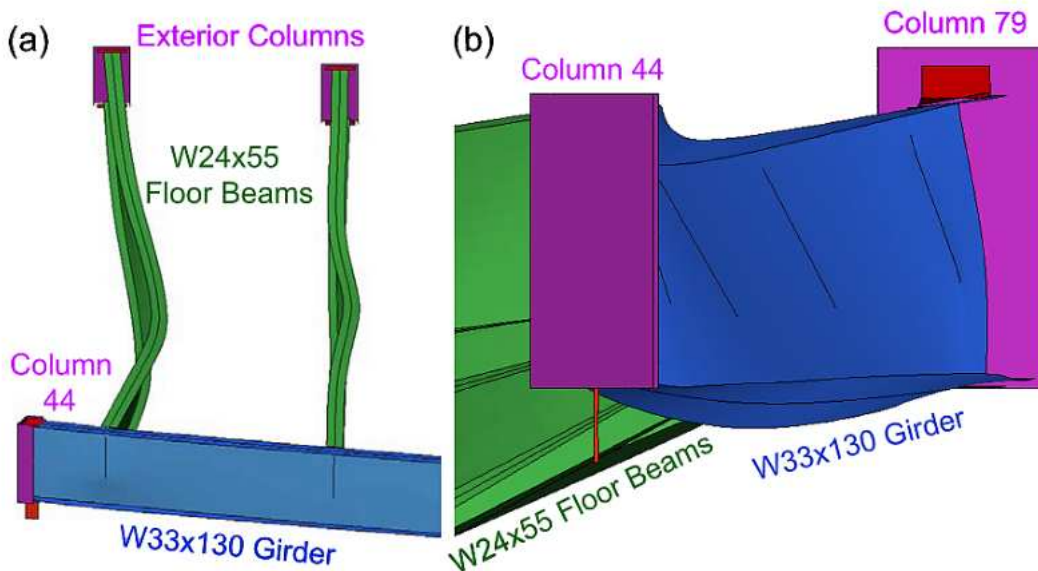
Figure 3.13 Figure 8-27 of the NIST report shows results of a finite element analysis where lateral support beams connecting to G3005 were not included (NIST, 2008, NCSTAR 1-9, Vol. 1, Page 354).

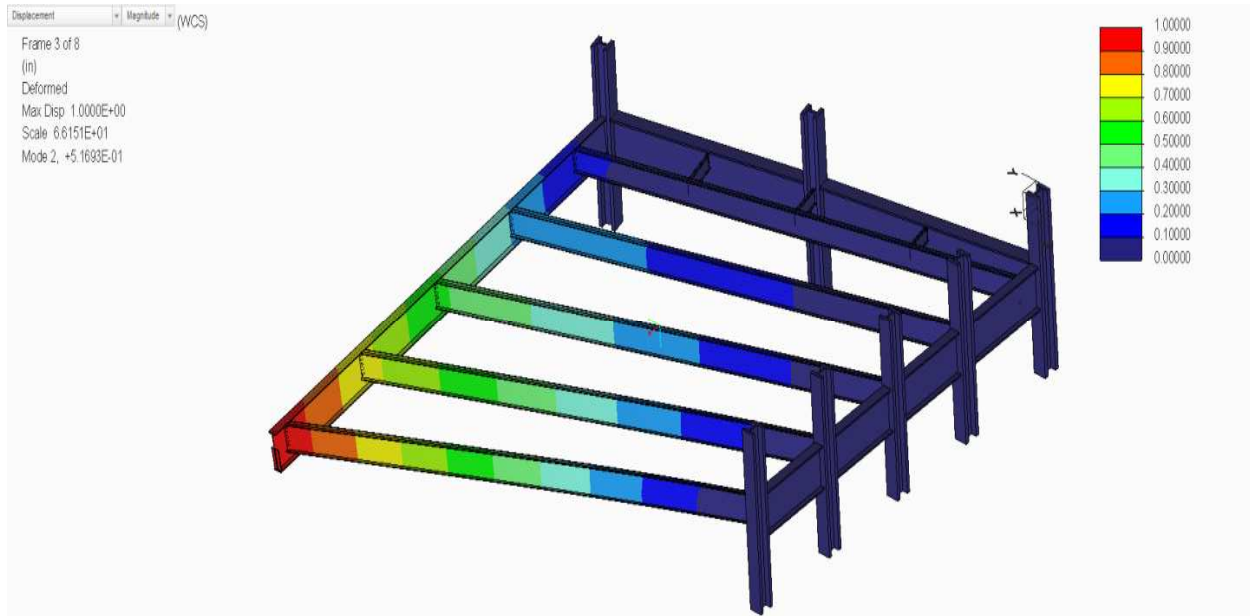
Figure 3.15 The relevant 0.52 Hz mode of the falling beam and girder assembly.

The natural frequency of mode 2 in the vertical direction is 0.51693 hz. The weight of the beam and girder assembly is approximately 20,000 lbs., so mass ( $m$ ) = 20,000/32.174 = 622 slugs. The concrete was not considered by Nordenson to act with the steel during the impact to amplify the load. This would be appropriate as the shear studs were broken and the welded wire fabric in the slab and the floor pans would keep it suspended to some degree. Knowing the natural frequency of the beam and girder assembly ( $f_n$ ), along with its mass ( $m$ ), stiffness could then be found using the equation

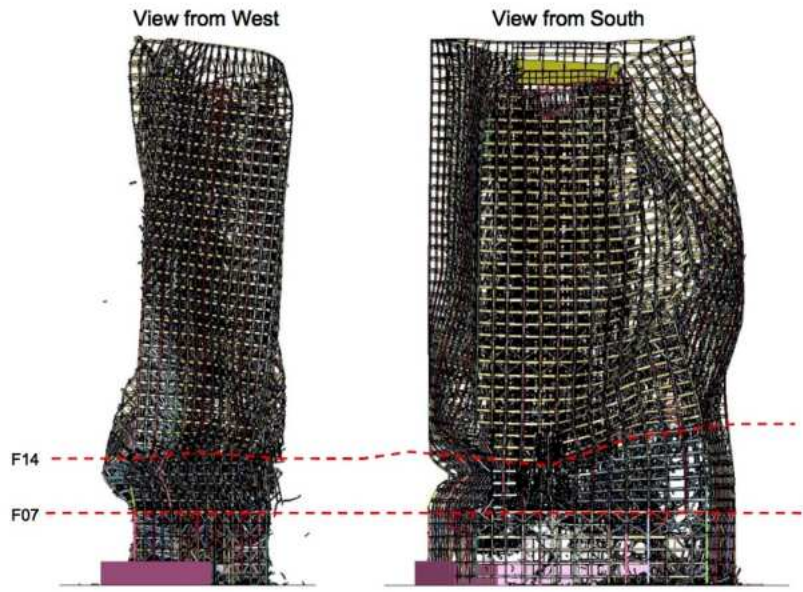
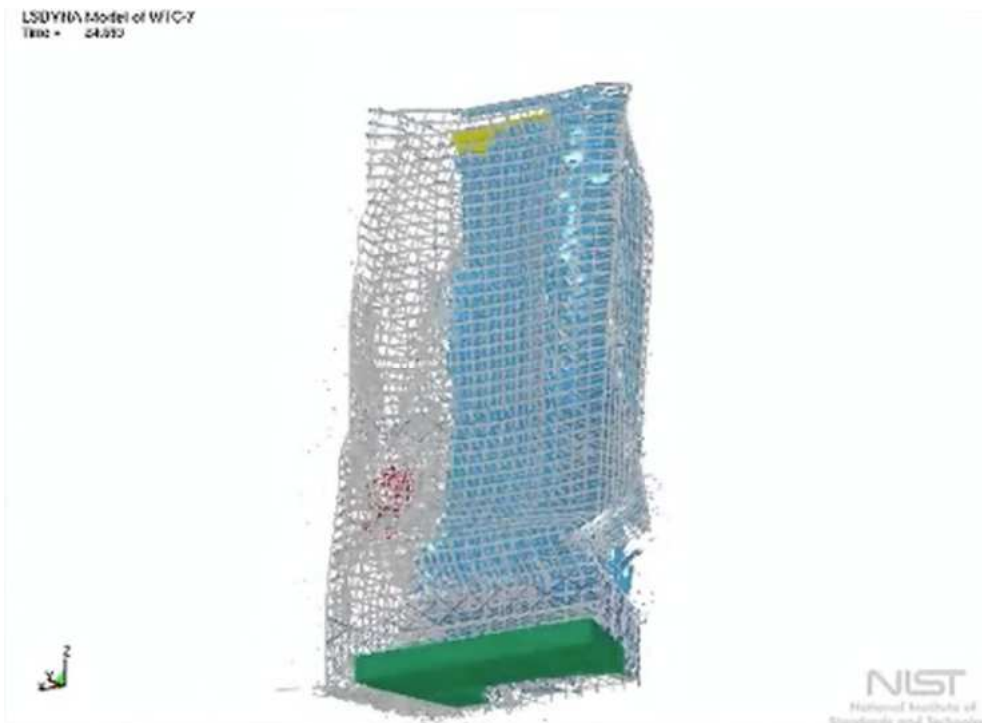
**Figure 4.1 NIST’s progressive collapse simulation.**

During our nonlinear connection study (Section 2.1.3.2), wherein we examined NIST's modeling of WTC 7's structural connections and its effect on NIST's progressive collapse simulation, we also observed that NIST's progressive collapse simulation did not closely resemble the observed collapse. While NIST's progressive collapse simulation does show the three key features listed above, it also predicts significant differential movements in the exterior, both before and during the fall of the roofline, that were not observed in the video (see Figures 4.1a and 4.1b). Such differential movements in the exterior would be extremely likely to have caused window breakage, cracking of the façade, and exterior deformation, none of which were observed. A major goal of our analysis was to identify failure mechanisms that would predict the minimal differential movement of the exterior seen in videos of the collapse.

(a) Illustration of NIST’s progressive collapse simulation showing significant differential movements in the exterior (NIST NCSTAR 1-9).

(b) NIST’s progressive collapse simulation showing significant differential movements in the exterior (NIST NCSTAR 1A).

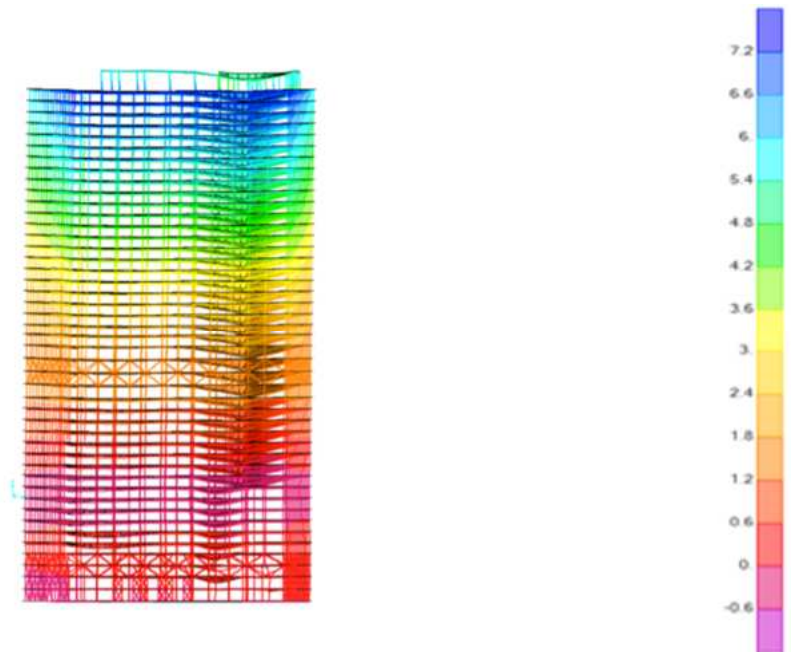
Figure 4.3: Columns 79, 80, and 81 are removed from Floor 13 to Floor 21. The building tilts to the east 7.2 inches. The penthouse does not collapse.

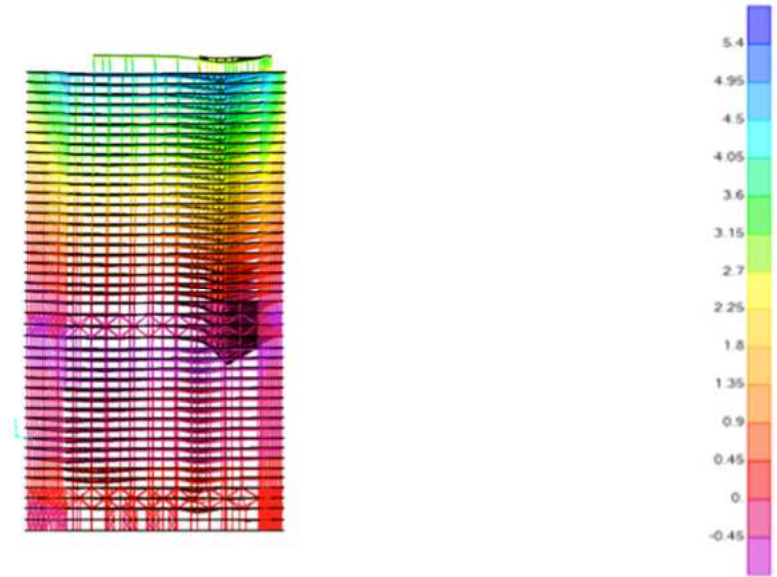
Figure 4.4: Columns 79, 80, and 81 are removed from Floor 21 to Floor 29. The building tilts to the east 5.4 inches. The penthouse does not collapse, though penthouse deflection increases.

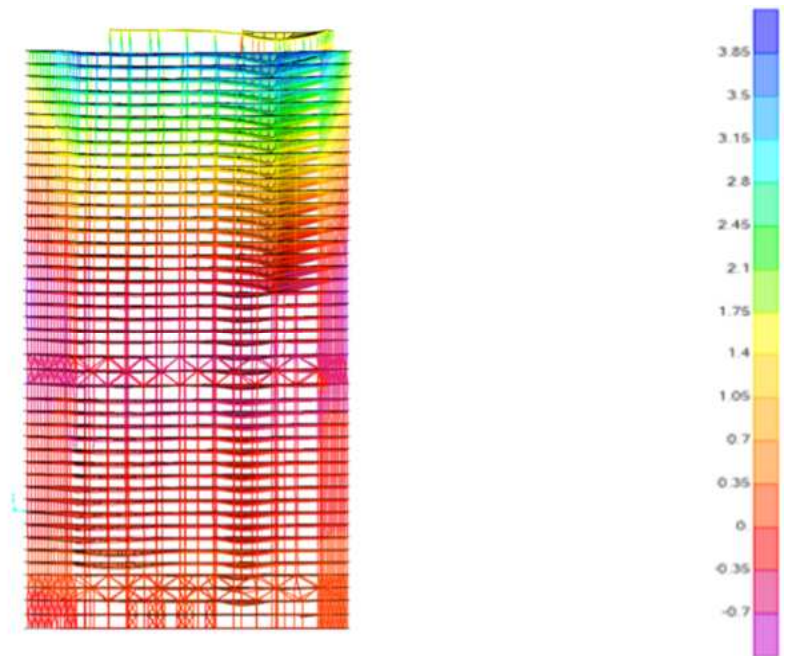
Figure 4.5: Columns 79, 80, and 81 are removed from Floor 29 to Floor 37. The building tilts to the east 3.85 inches. The penthouse does not collapse, though its deflection increases.

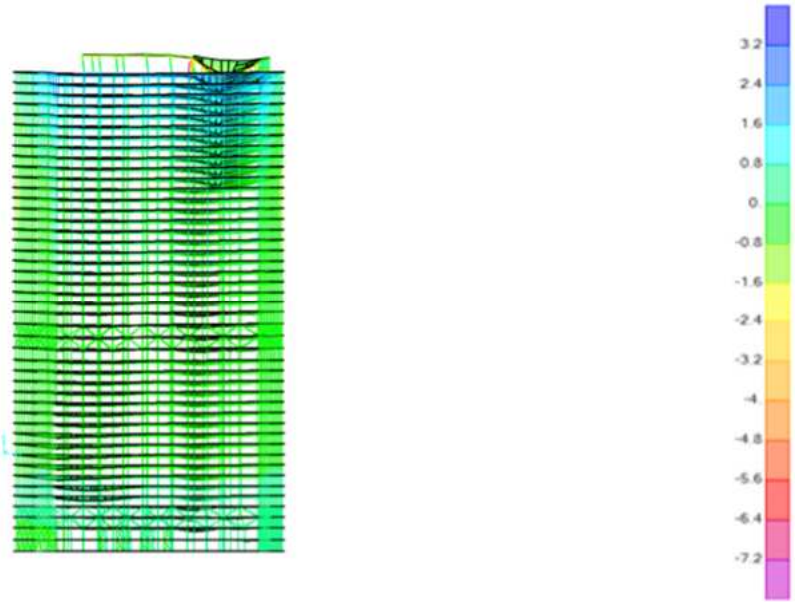
Figure 4.6: Columns 79, 80, and 81 are removed from Floor 37 to Floor 45. Tilting of the building is now negligible, whereas the deflection of the penthouse is now much greater.

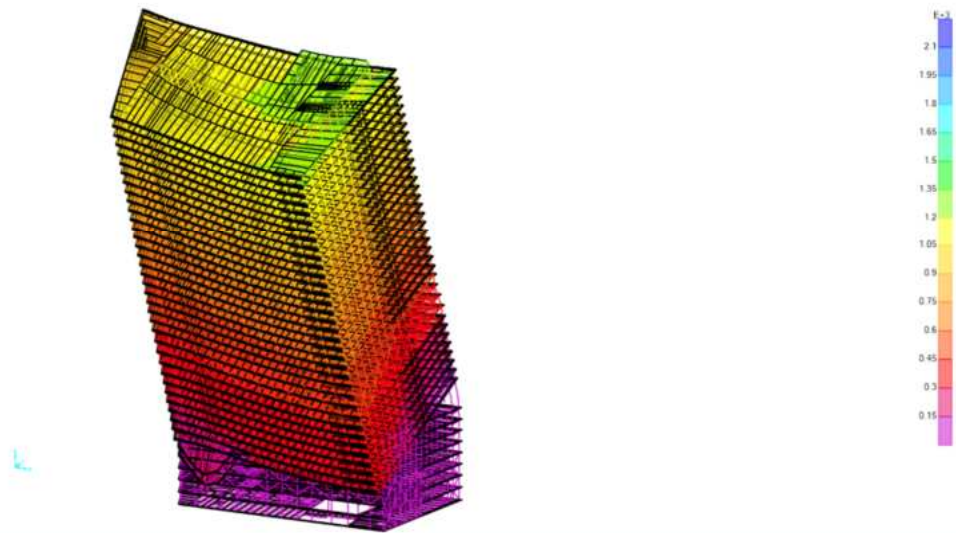
Going one step further, we simulated the failure of Columns 76, 77, and 78, even though these columns would not buckle due to the loss of Columns 79, 80, and 81. With the removal of six core columns on the eastern side of the building (Columns 76 through 81), we found that a total collapse of the building would ensue. First, the axial loads on the exterior columns around the southeastern corner of the building would exceed design loads, causing these exterior columns to fail. The failure of these exterior columns would then cause the axial loads on most of the remaining core columns and some of the remaining exterior columns to exceed design loads, resulting in those columns failing and leading shortly thereafter to total collapse. However, rather than a straight-down collapse as observed, the building would tip to the southeast, as illustrated in Figures 4.14, 4.15, and 4.16 below.

Figure 4.14: Visualization of linear static analysis, from the southeast, showing the building tipping to the southeast after the hypothetical failure of Columns 76 to 81.

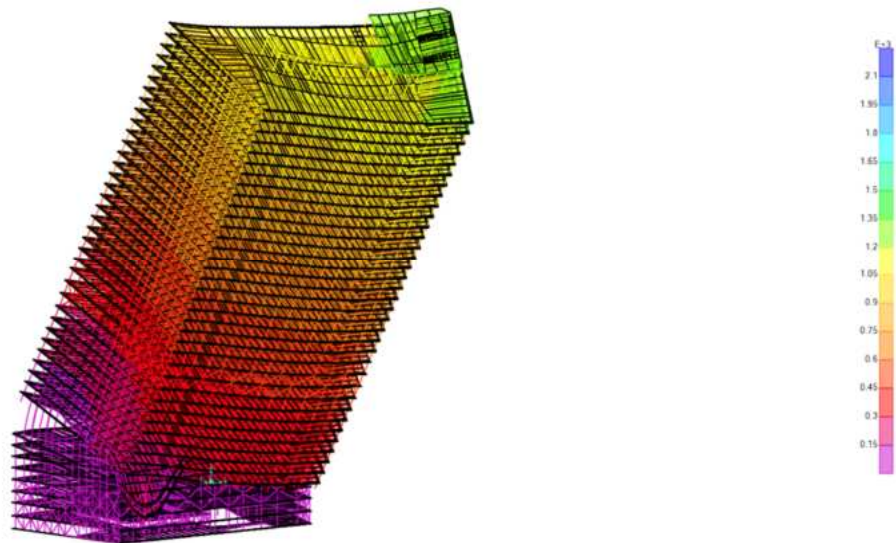
Figure 4.15: Visualization of linear static analysis, from the southwest, showing the building tipping to the southeast after the hypothetical failure of Columns 76 to 81.

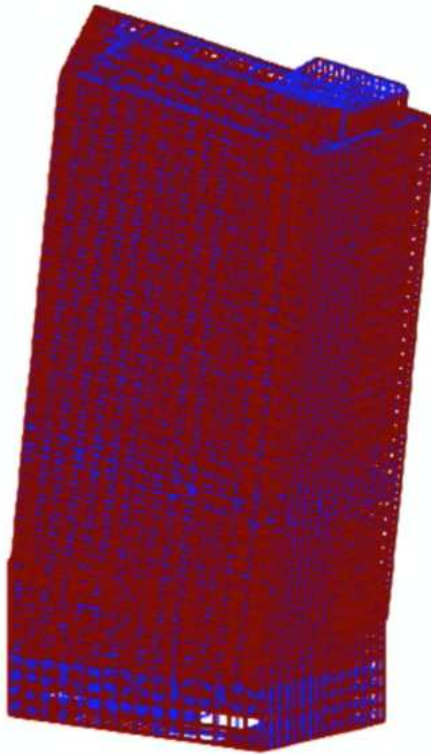
Figure 4.16: Dynamic analysis results showing the building tipping to the southeast after the hypothetical failure of Columns 76 to 81.

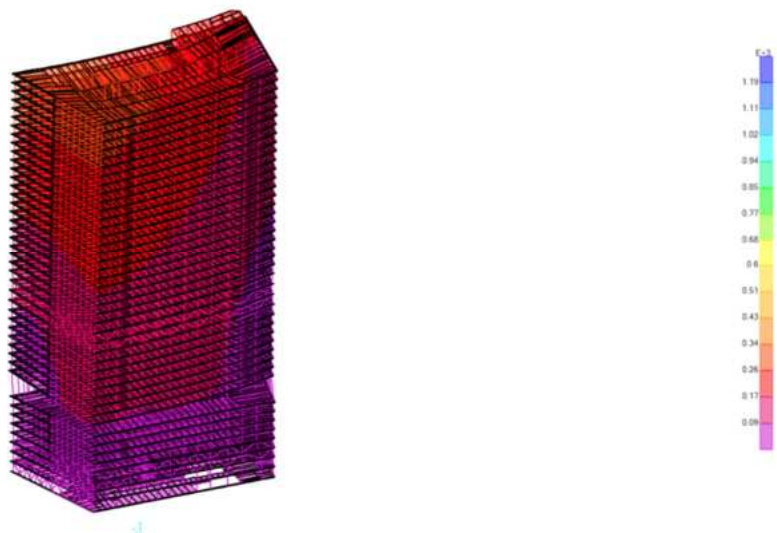
Figure 4.19: Visualization of linear static analysis, from the southwest, showing the building tipping to the southwest after the hypothetical simultaneous failure of all core columns.

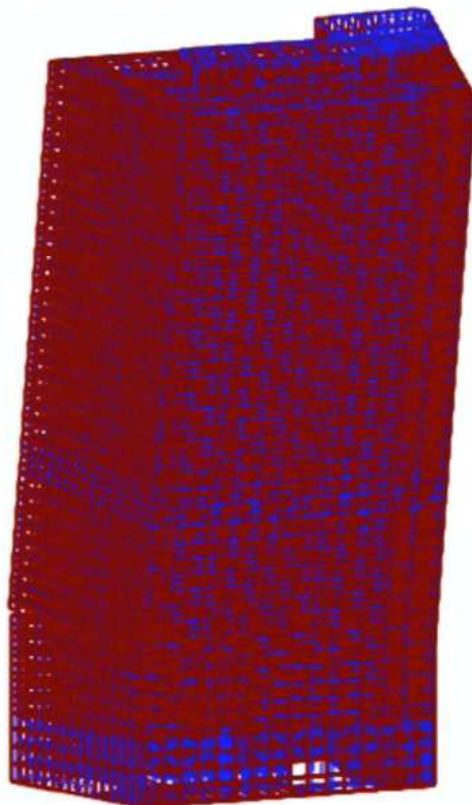
Figure 4.20: Dynamic analysis results showing the building tipping to the southwest after the hypothetical simultaneous failure of all core columns.

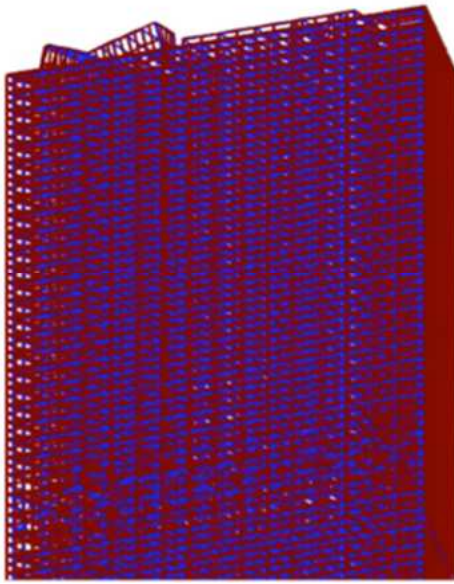
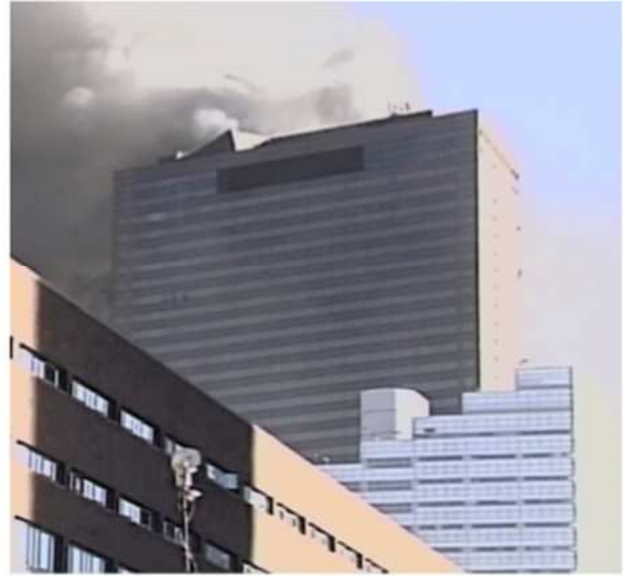
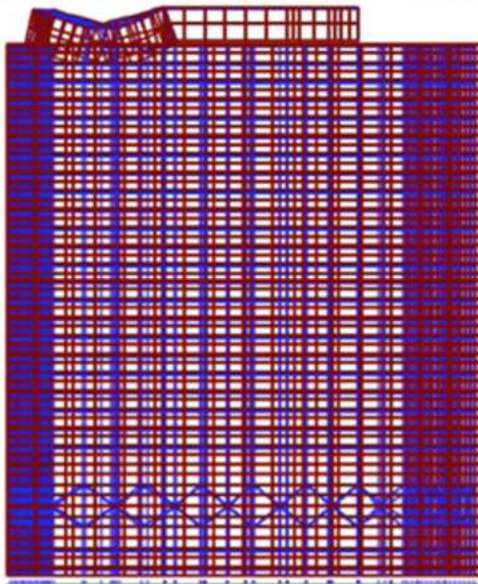
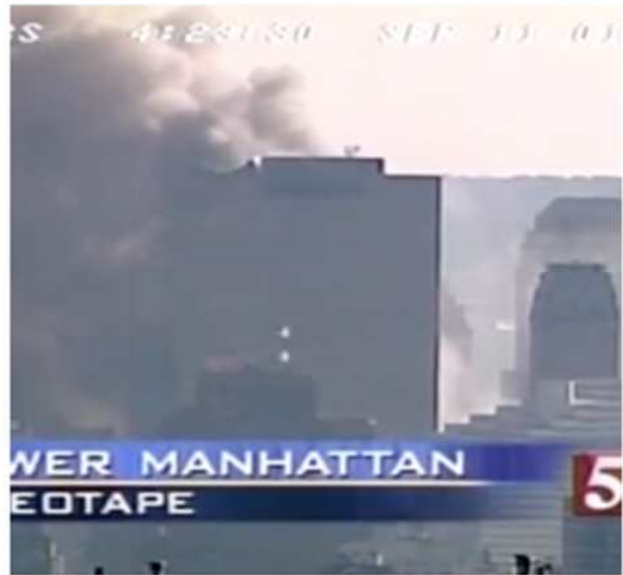
Figure 4.24: (a) Comparison of simulated collapse to perspective 1; (b) comparison of simulated collapse to perspective 2.

Based on this analysis, we found that the simultaneous failure of all core columns followed by the simultaneous failure of all exterior columns produces almost exactly the behavior observed in videos of the collapse. Specifically, the simulated velocity and acceleration of the building in our SAP2000 model matches almost exactly with the motion measured by David Chandler (Chandler, 2010), including the approximately 2.5 seconds of free fall, shown in Figures 4.21, 4.22, and 4.23 below.
