# **A Structural Reevaluation of the Collapse of World Trade Center 7**

***Draft***

**INE Report 18.17**

**September 2019**

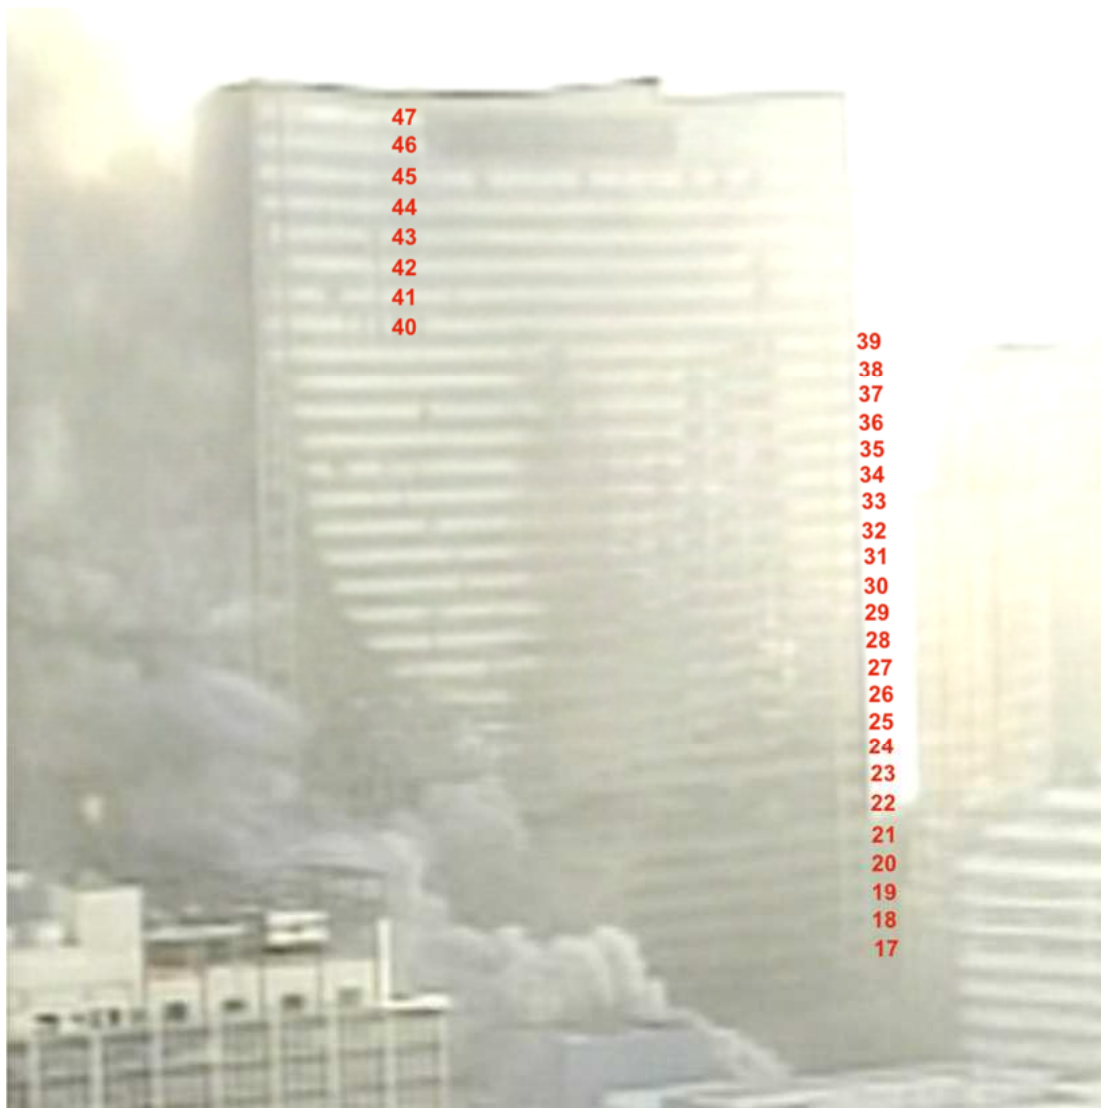
12 to Floor 19; the second was the failure of all columns from Floor 6 to Floor 13. The two simulations were identical in terms of the downward velocity and acceleration of the northwest corner at the top of building. We therefore found that the collapse could have started at various floors. Based on our subsequent review of video footage, we found that Floor 16 is the uppermost floor where the collapse could have initiated, because the video shows Floor 17 to Floor 47 falling uniformly as a unit (see Figure 4.25 below). Although some floors below Floor 17 are somewhat visible in the video, it cannot be determined with confidence that they are falling as a unit with the floors above.

Figure 4.25: Floors 17 to 47 falling uniformly as a unit (CBS).
